**AGENDA**  
for the meeting of the Open Spaces Management Committee

*Report Reference: TS00123\_HATBR\_5888*

*Client: Hatfield Broad Oak Parish Council*

- 1.1 Longacre Tree Surgery consultation services have been asked by the representatives of Hatfield Broadoak Parish Council, to inspect all trees within a designated area. The purpose of this survey is to identify any potential risk associated with the physiological and structural condition of the stock.

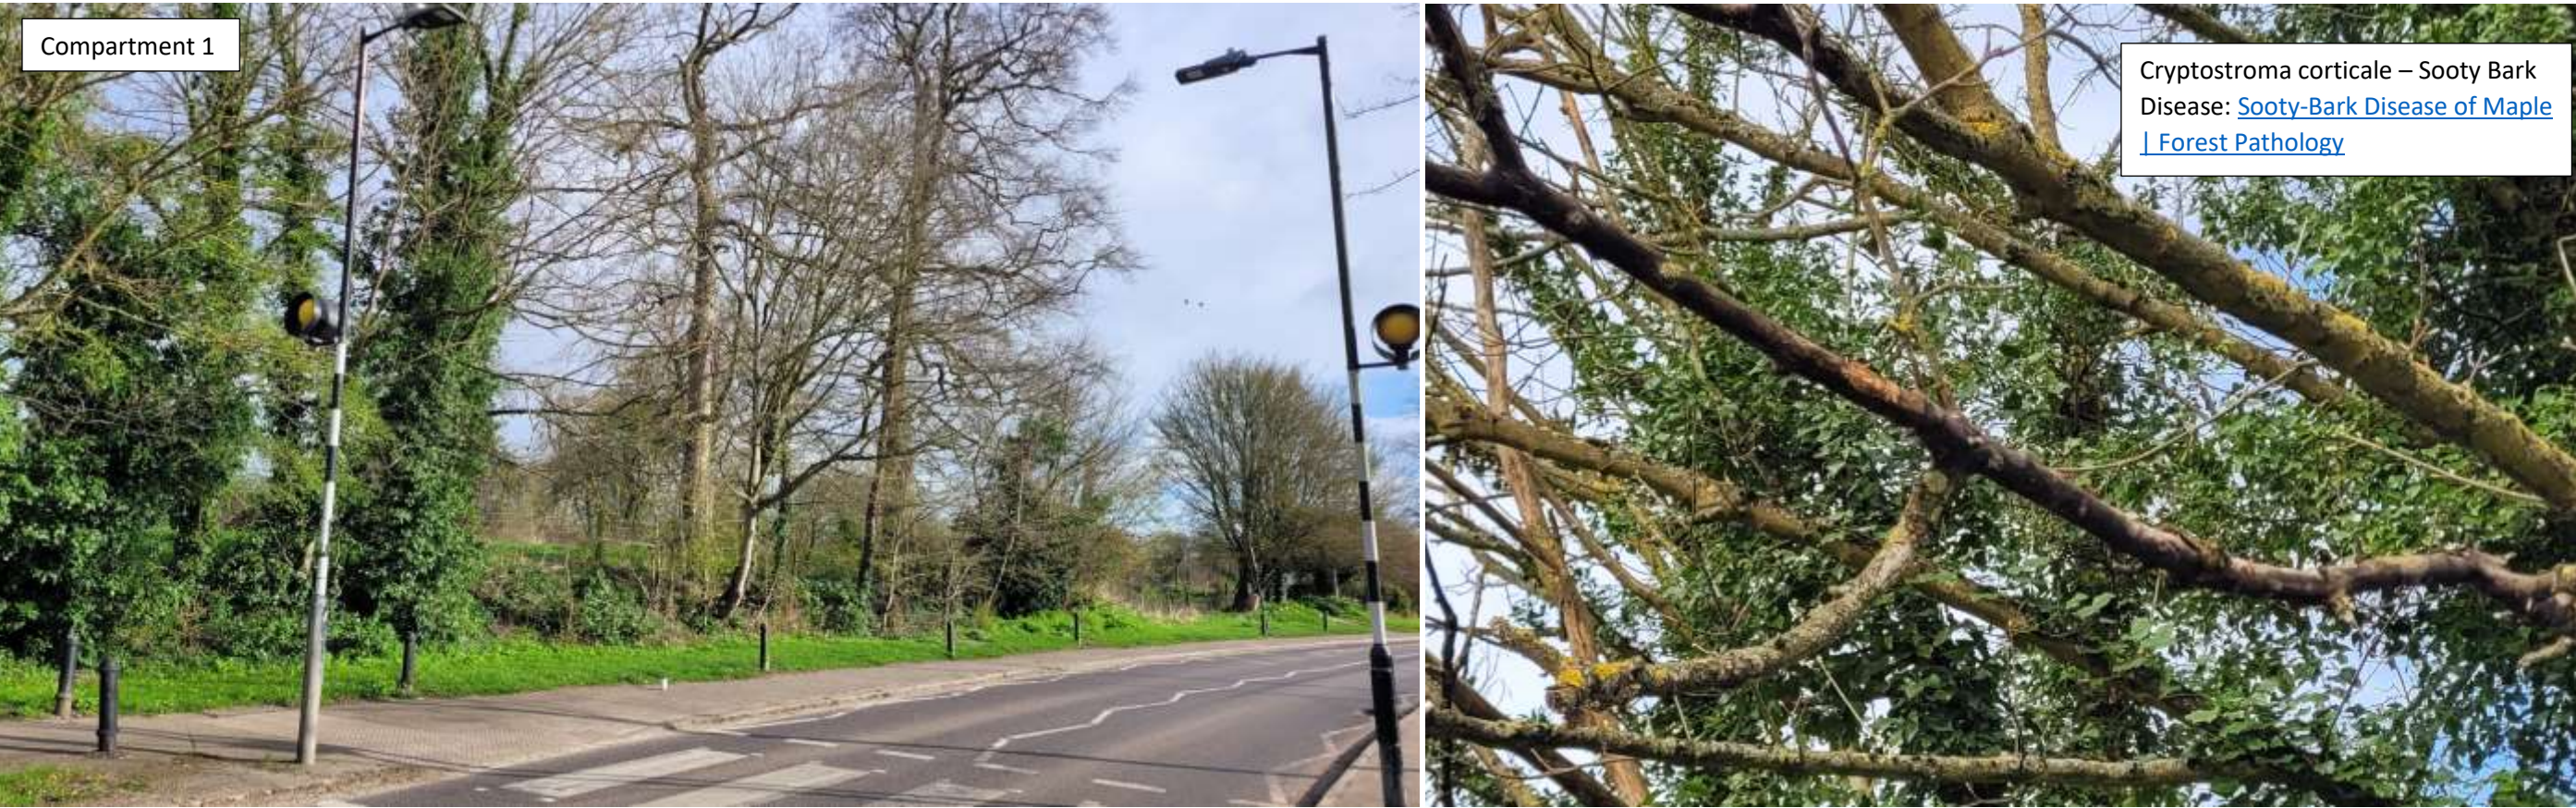
| FULL TREE SURVEY INSPECTION DATE – ATTENDED BY: PAUL ZEPLER AND CHRISTOPHER STILES | | | | | | | | | | | | | | | | | |
|---|---|---|---|---|---|---|---|---|---|---|---|---|---|---|---|---|---|
| 3499 | 8 | Field Maple | C1 Opposite School | 210 | 12 | 10 | Semi Mat | | Good | Good | Good | Good | Good | low growth | Crown lift 3m | | 3 |
| COMPARTMENT 1 OVERVIEW | Sooty bark present within stock this will require monitoring of the Sycamore on an annual basis to gauge the progression. Low growth over road will be a restriction to high sided vehicles sometime within the next 12 month. Flail works apparent but not to extra heavy vehicle height i.e.4.6m. | | | | | | | | | | | | | | | | |

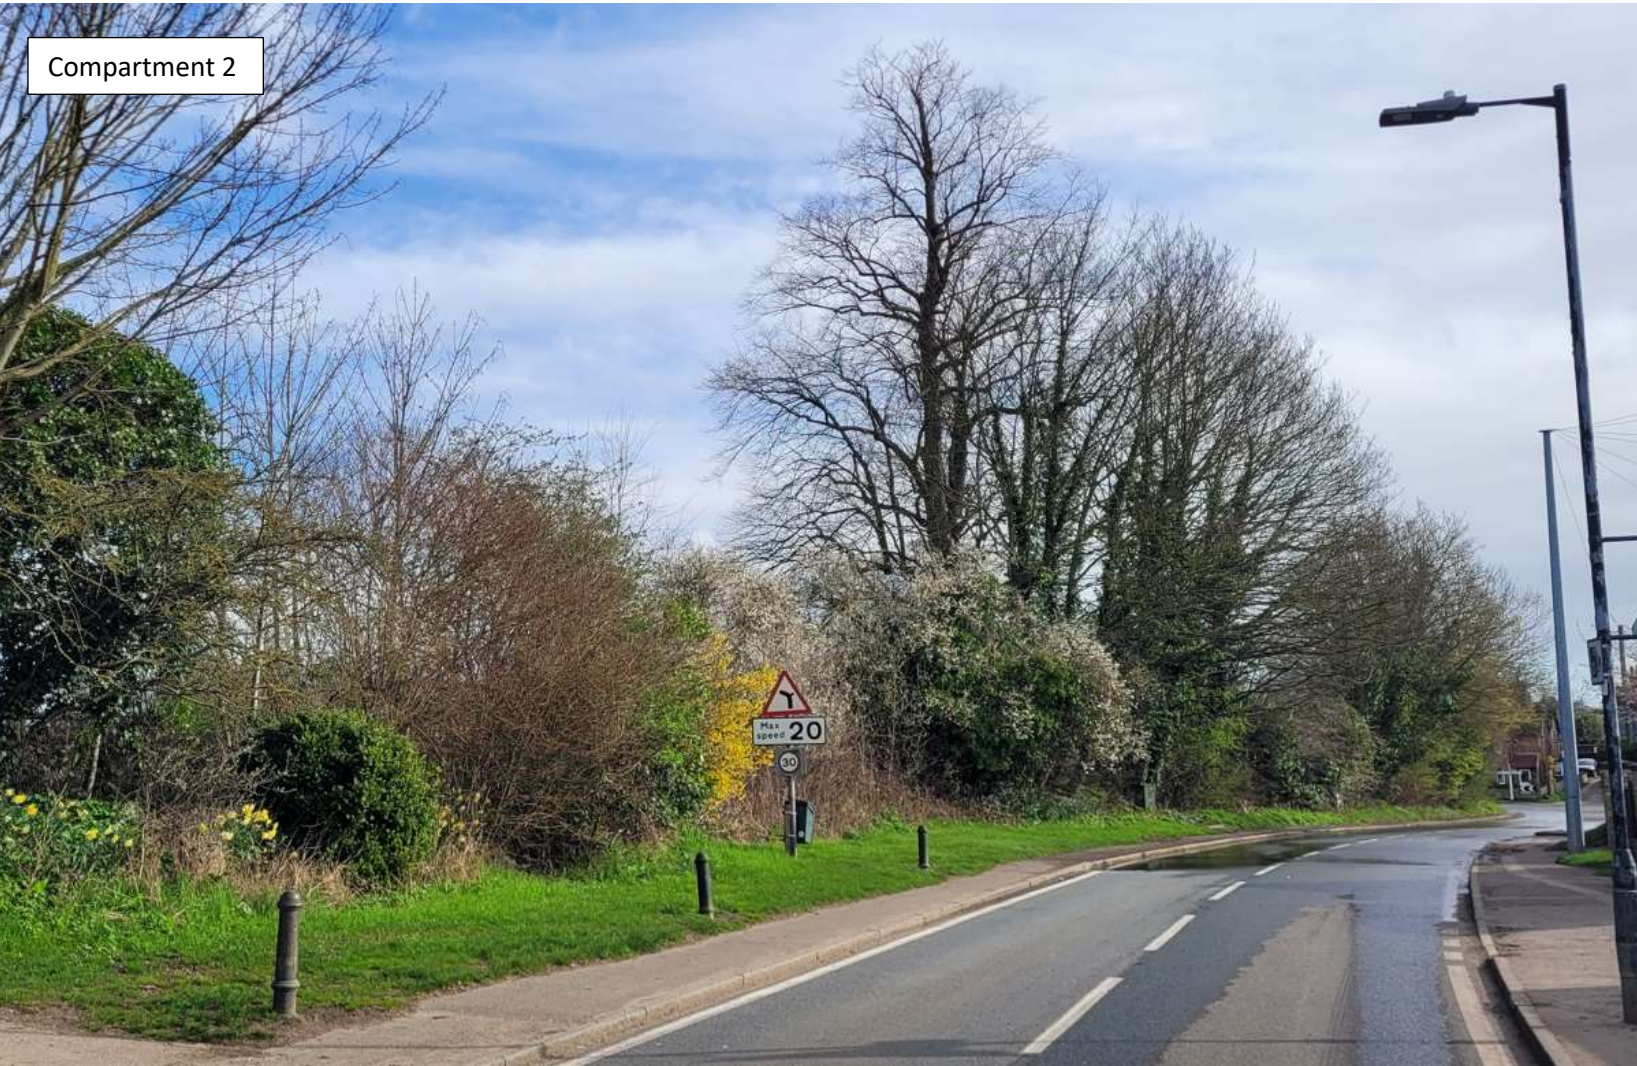
| Tag ref | Map ref | Species | Location | DBH (mm) | Height (m) | Radial crown spread (m) | Age | Crown | Crown break | Stem | Root crown | Rooting area | Overall Condition | Comments | Recommendation(s) | Risk | Priority |
|---|---|---|---|---|---|---|---|---|---|---|---|---|---|---|---|---|---|
| 3502 | 11 | Lime | C2 Opposite Orchard End | 900-1000 | 24 | 17 | Mature | Fair | Good | Fair | localised decay | Root ball degradation | Fair | Basal growth, localised | Deadwood, monitor 12 | | 2 |
| 3508 | 17 | Ash | C2 Opp pub | 350 | 16 | 9 | Mature | Good | Good | Forked stem - Good | Good | Good | Good | N/A | Crown lift 5m, 50% cut back of road overhang | | 3 |
| COMPARTMENT 2 OVERVIEW | Sooty bark present within stock this will require monitoring of the Sycamore on an annual basis to gauge the progression. Low growth over road will be a restriction to high sided vehicles sometime within the next 12 month. Flail works apparent but not to extra heavy vehicle height. | | | | | | | | | | | | | | | | |

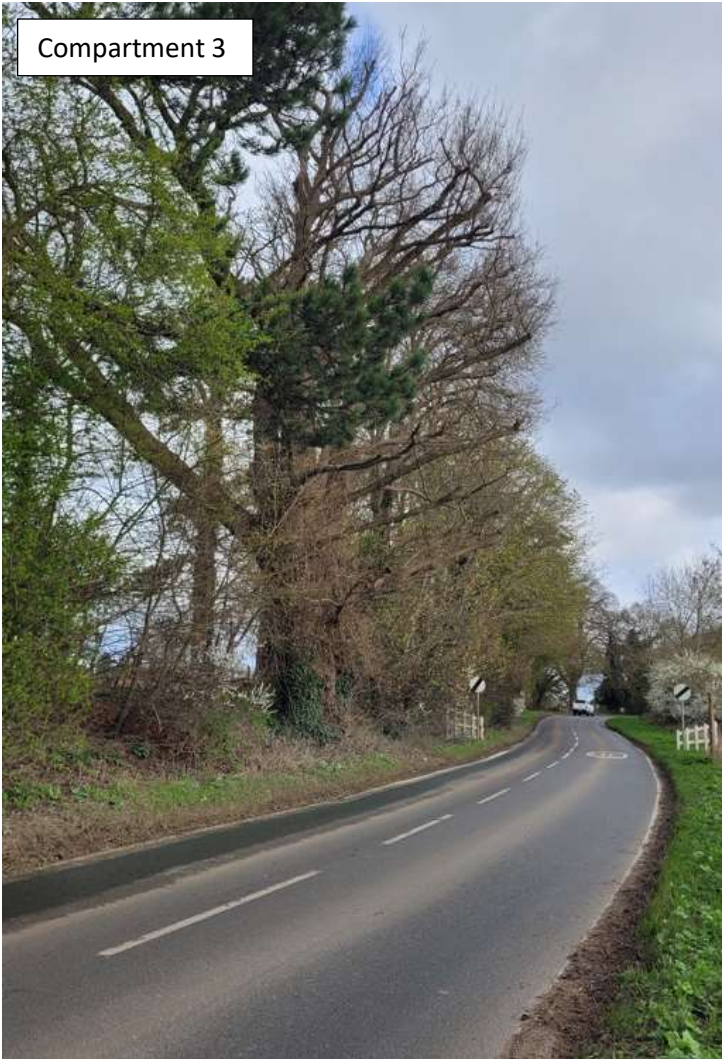
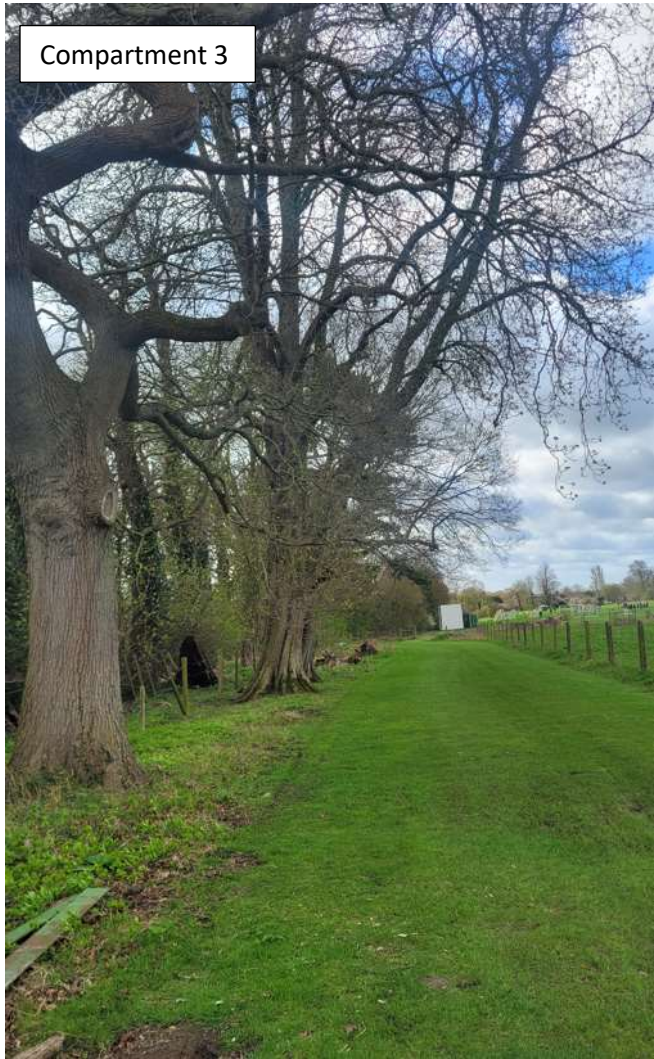
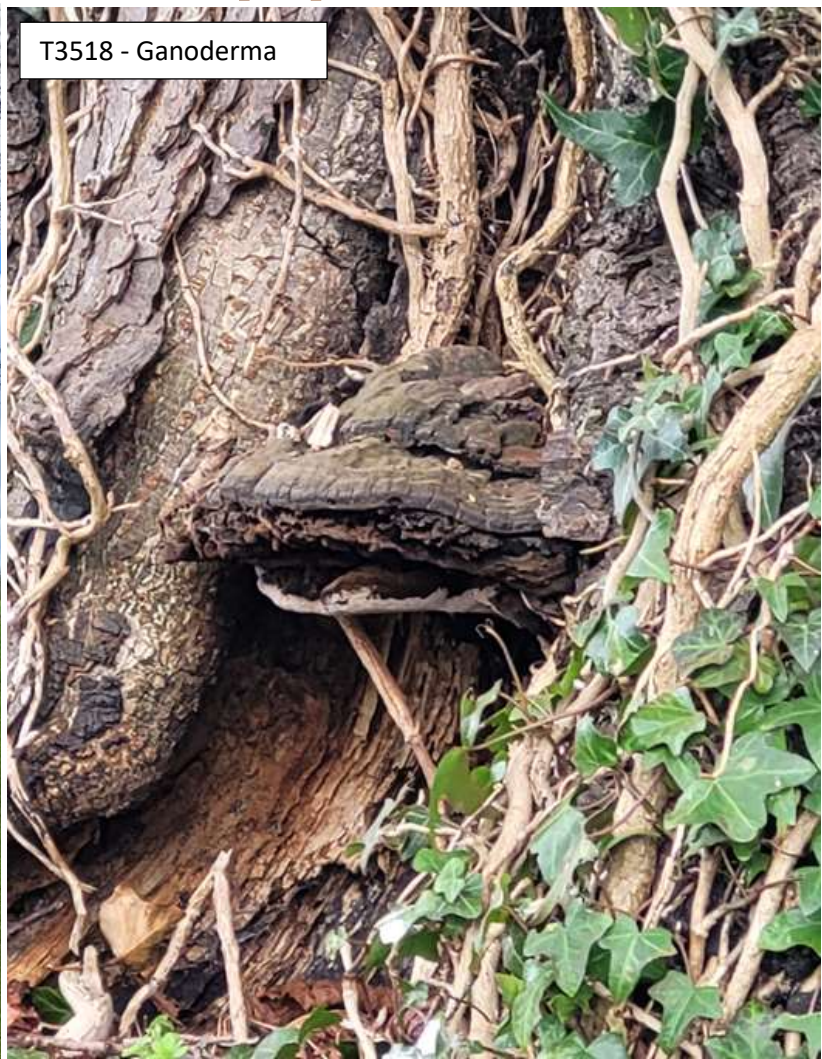
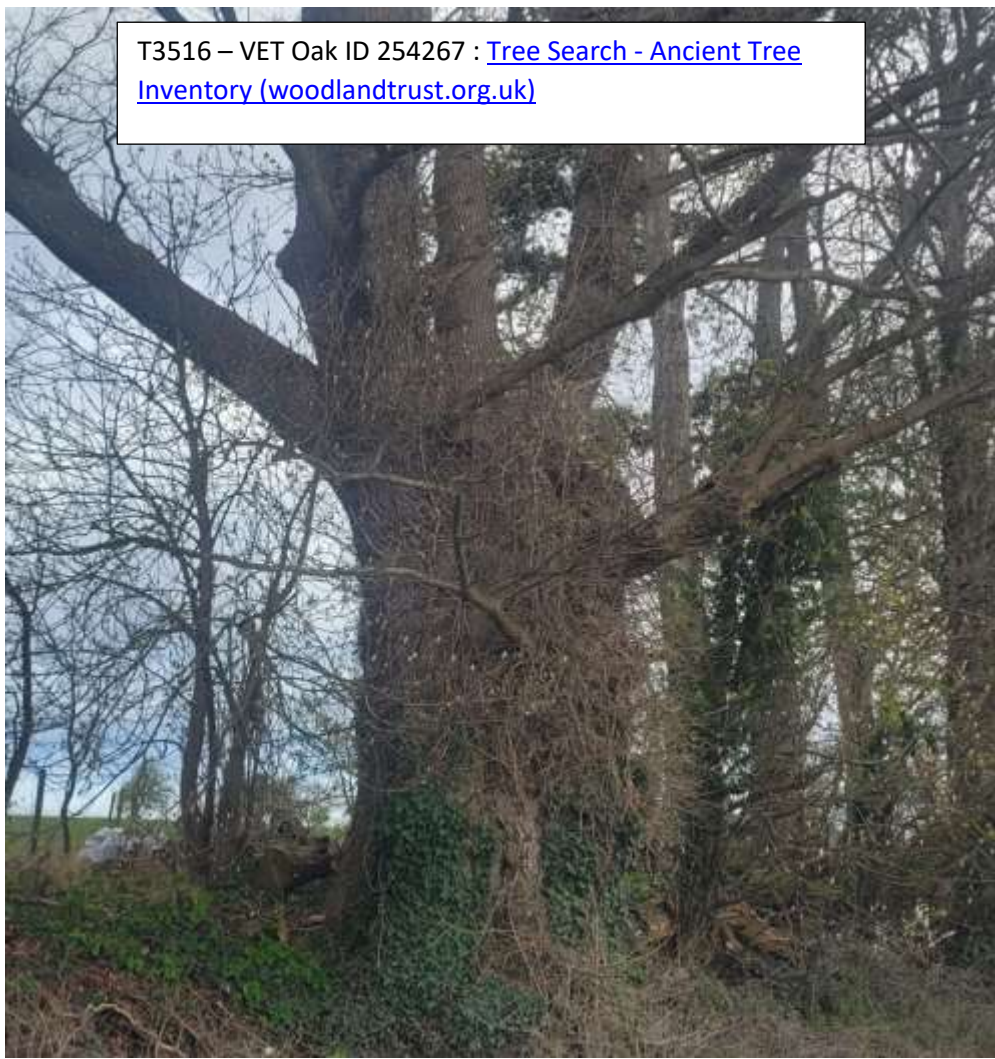
| Tag ref | Map ref | Species | Location | DBH (mm) | Height (m) | Radial crown spread (m) | Age | Crown | Crown break | Stem | Root crown | Rooting area | Overall Condition | Comments | Recommendation(s) | Risk | Priority |
|---|---|---|---|---|---|---|---|---|---|---|---|---|---|---|---|---|---|
| 3509 | 18 | Hawthorn | C3 opposite Bickmere Cottage | 180 | 7 | 5 | Mature | heavily weighted with Ivy | Good | Good | Good | Good | Fair | N/A | 2m cut back from road | | 3 |
| 3520 | 29 | Ash | C3 adjacent to field entrance | 300 | 15 | 11 | Mature | Good | Good | multi stem | Good | Good | Fair | N/A | Deadwood, crown lift 5m | | 2 |
| COMPARTMENT 3 OVERVIEW | Sooty bark present within stock this will require monitoring of the Sycamore on an annual basis to gauge the progression. Low growth over road will be a restriction to high sided vehicles sometime within the next 12 month. Flail works apparent but not to extra heavy vehicle height. Group of Horse chestnut found to be in poor condition. Collapse of these would potentially be onto the public carriageway, mitigation works, and annual monitoring required. | | | | | | | | | | | | | | | | |

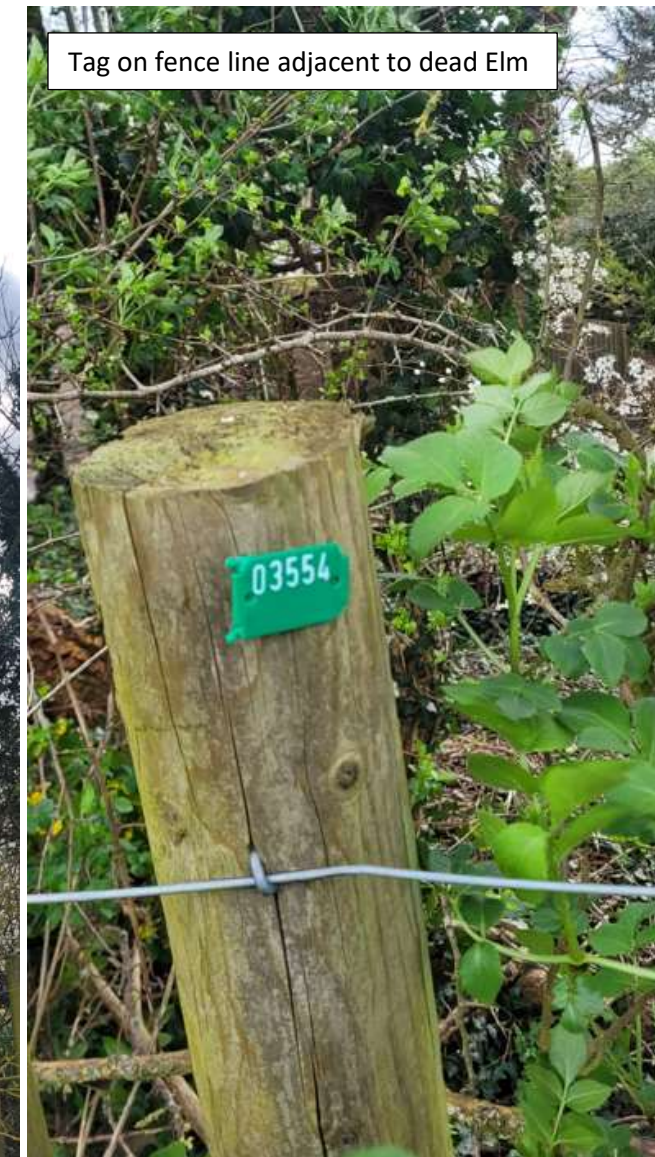
| Tag ref | Map ref | Species | Location | DBH (mm) | Height (m) | Radial crown spread (m) | Age | Crown | Crown break | Stem | Root crown | Rooting area | Overall Condition | Comments | Recommendation(s) | Risk | Priority |
|---|---|---|---|---|---|---|---|---|---|---|---|---|---|---|---|---|---|
| 3554 | 30 | Elm x5 | C4 Football pitches, road adjacent | 100 | 7 | 3 | young tree | Good | Good | Good | Good | Good | dead | tag on post | Fell to ground level | | 3 |
| 3555 | 31 | Ash | C4 Football pitches, road adjacent within ecological area | 400 | 6 | 2 | Mature | Poor | Poor | Poor | Poor | Good | Poor | Prenniporia fraxinea (ffb) – Tree well managed, reduced to prevent failure | N/A | | |
| COMPARTMENT 4 OVERVIEW | No risk associated with area apart from pocket of dead elm adjacent to fence line. Ecological areas are closed off to public. | | | | | | | | | | | | | | | | |

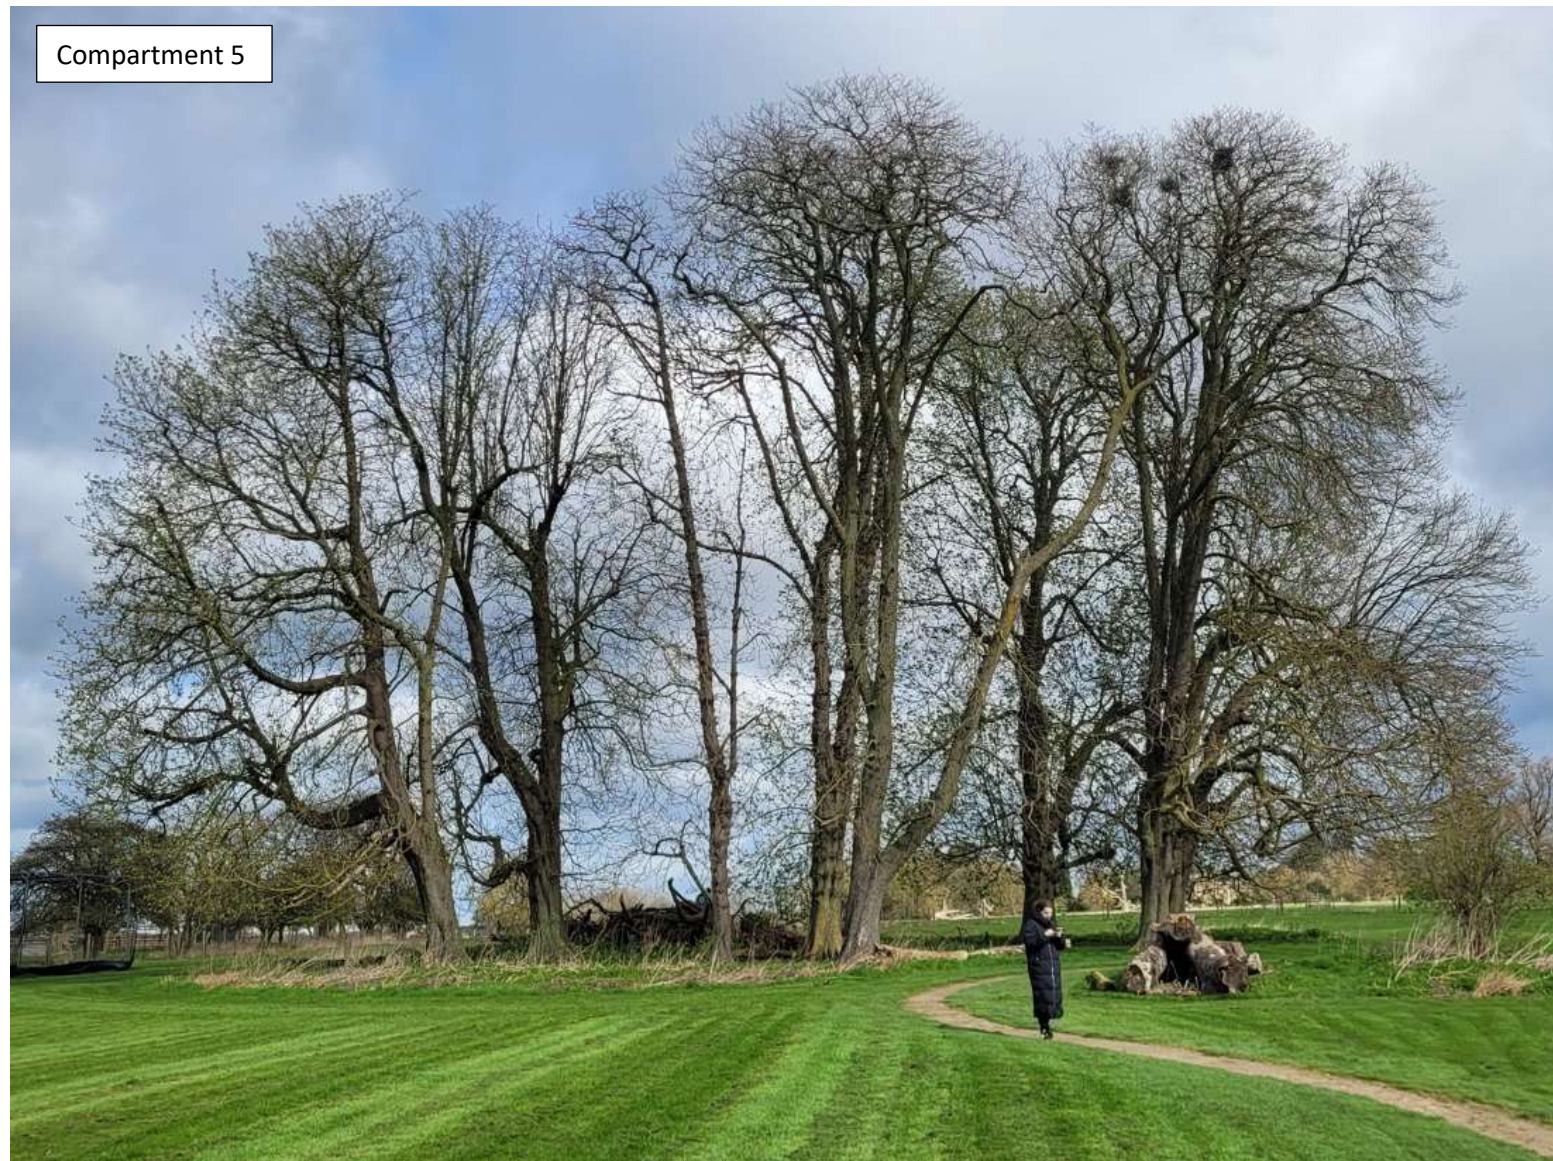
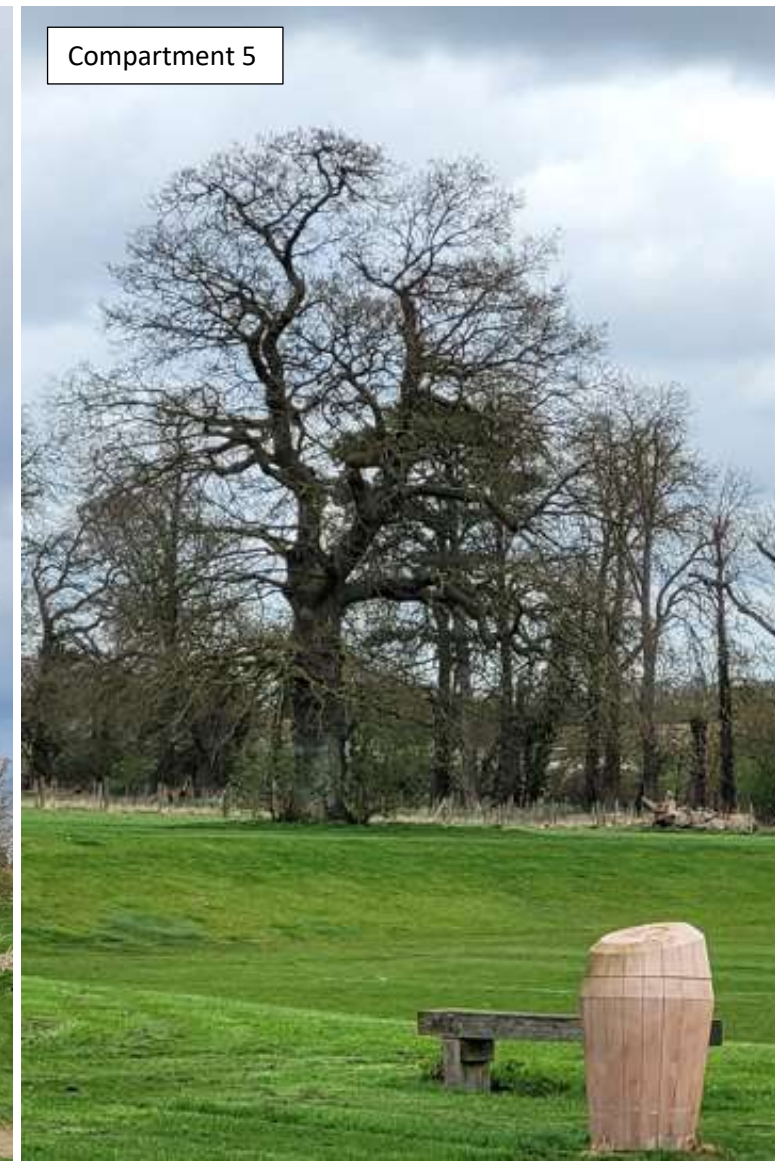
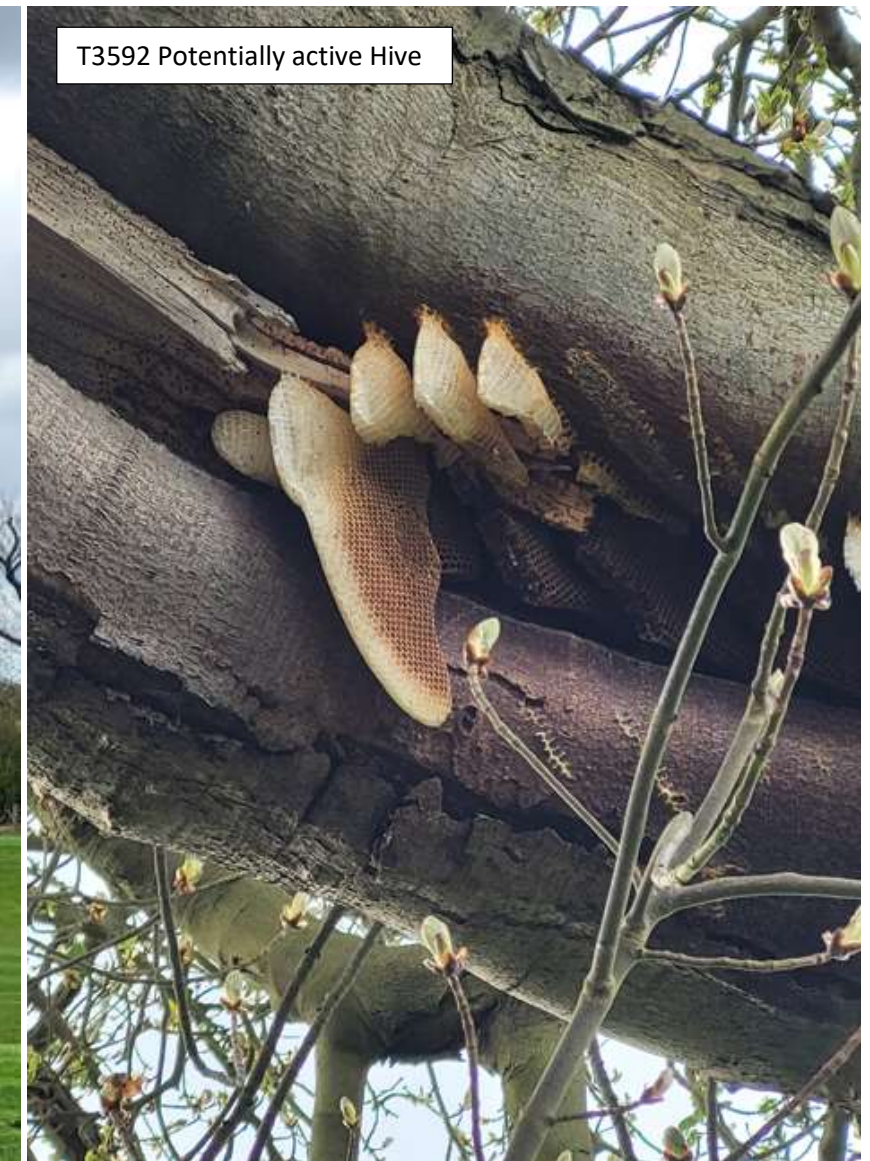
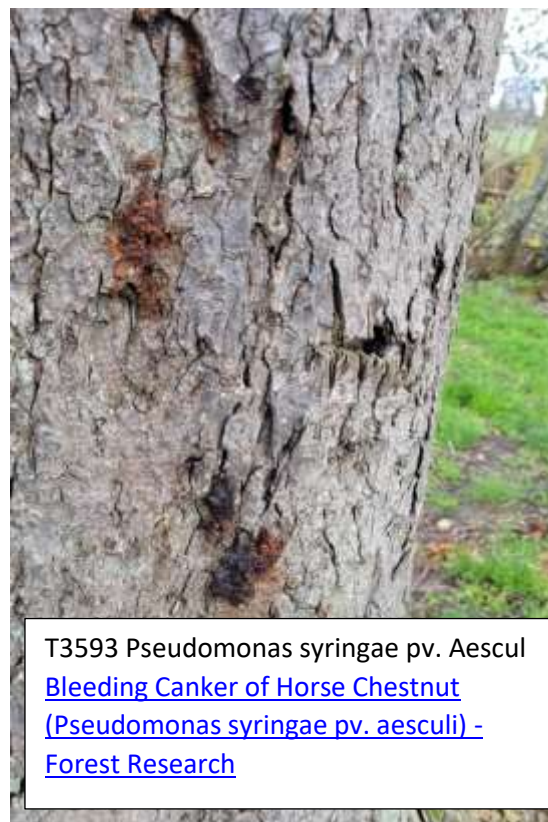
| Tag ref | Map ref | Species | Location | DBH (mm) | Height (m) | Radial crown spread (m) | Age | Crown | Crown break | Stem | Root crown | Rooting area | Overall Condition | Comments | Recommendation(s) | Risk | Priority |
|---|---|---|---|---|---|---|---|---|---|---|---|---|---|---|---|---|---|
| 3586 | 32 | Chestnut | C5 fields open area, footpath adjacent - Copse | 780 | 17 | 9 | Mature | asymmetrical, abscission limb @5m | Good | Fair | Good | Good | Good | Nesting wildlife | Crown lift 3m over footpath | | 2 |
| 3588 | 34 | Chestnut | C5 fields open area, footpath adjacent - Copse | 830 | 11 | 8 | Mature | Poor - Limb abscission, crown fracture | Poor | Fair | Good | Good | Fair | Historic crown reduction to manage weight distribution over cavity. | N/A | | |
| 3589 | 35 | Chestnut | C5 fields open area, footpath adjacent - Copse | 1000 | 18 | 14 | | limb abscission, white rot within limb on secondary stem - Poor | Fair | Good | Good | Good | Fair | N/A | N/A | | |
| 3592 | 38 | Chestnut | C5 fields open area, footpath adjacent - Copse | 820 | 17 | 13 | Mature | Honeycomb in decayed limb - Fair | Good | Fair | Good | Good | Fair | Potentially active hive | N/A | | |
| 3593 | 39 | Chestnut | C5 fields open area, footpath adjacent - Copse | 480 | 16 | 5 | Mature | suppressed canopy, failed secondary leader, dead tertiary leader | Good | Fractured stem | Poor | Poor | Poor | Pseudomonas bacterial infection | Remove dead stem + deadwood and fully survey in 12 months | | 2 |
| 3595 | 41 | Oak | C5 - Standalone Oak adjacent to football field | 1200 | 15 | 15 | Mature | Good | Good | Good | habitation holes, elder growing at base | footpath within canopy dripline | Good | deadwood indicative of species | Crown lift 3m over footpath, remove basal suckers and invasive growth | | 3 |

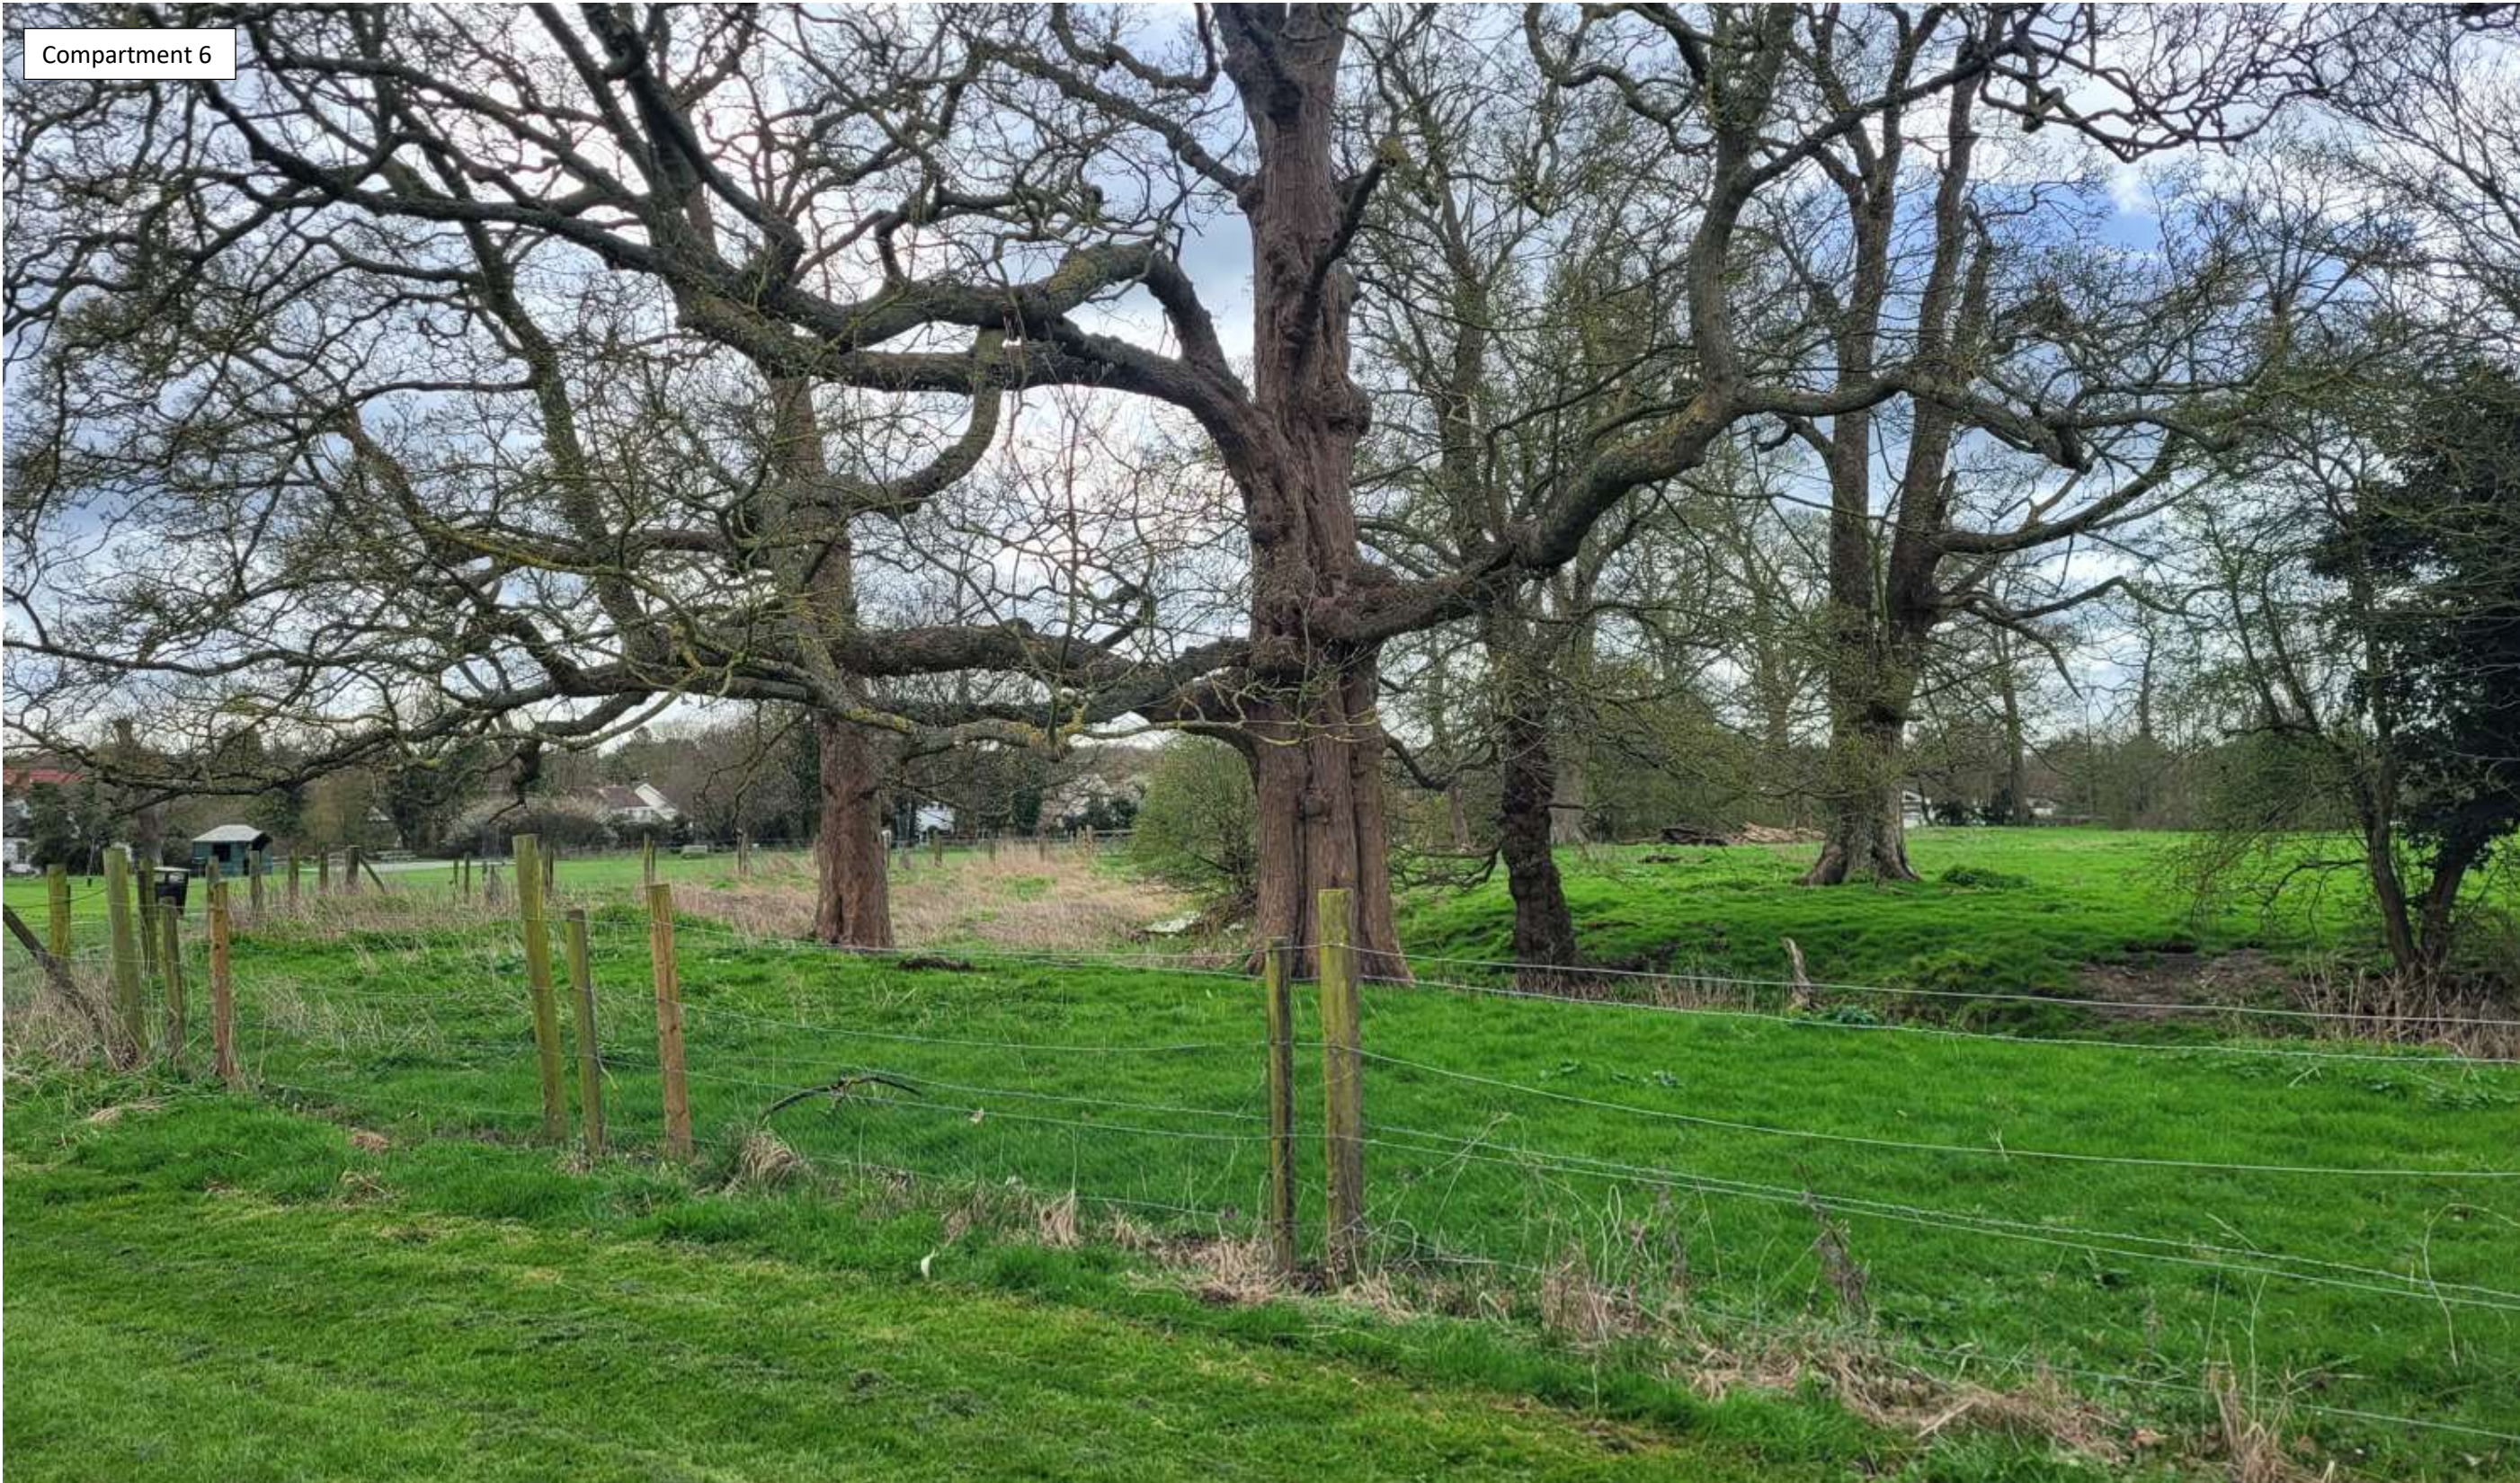
| MAP/ Tag ref | Species | Location | DBH (mm) | Height (m) | Radial crown spread (m) | Age | Crown | Crown break | Stem | Root crown | Rooting area | Overall Condition | Comments | Recommendation(s) | | |
|---|---|---|---|---|---|---|---|---|---|---|---|---|---|---|--|--|
| COMPARTMENT 6 OVERVIEW | No risk associated with land due to occupations. Land is likely only associated with the Parish due to Riparian ownership | | | | | | | | | | | | | | | |

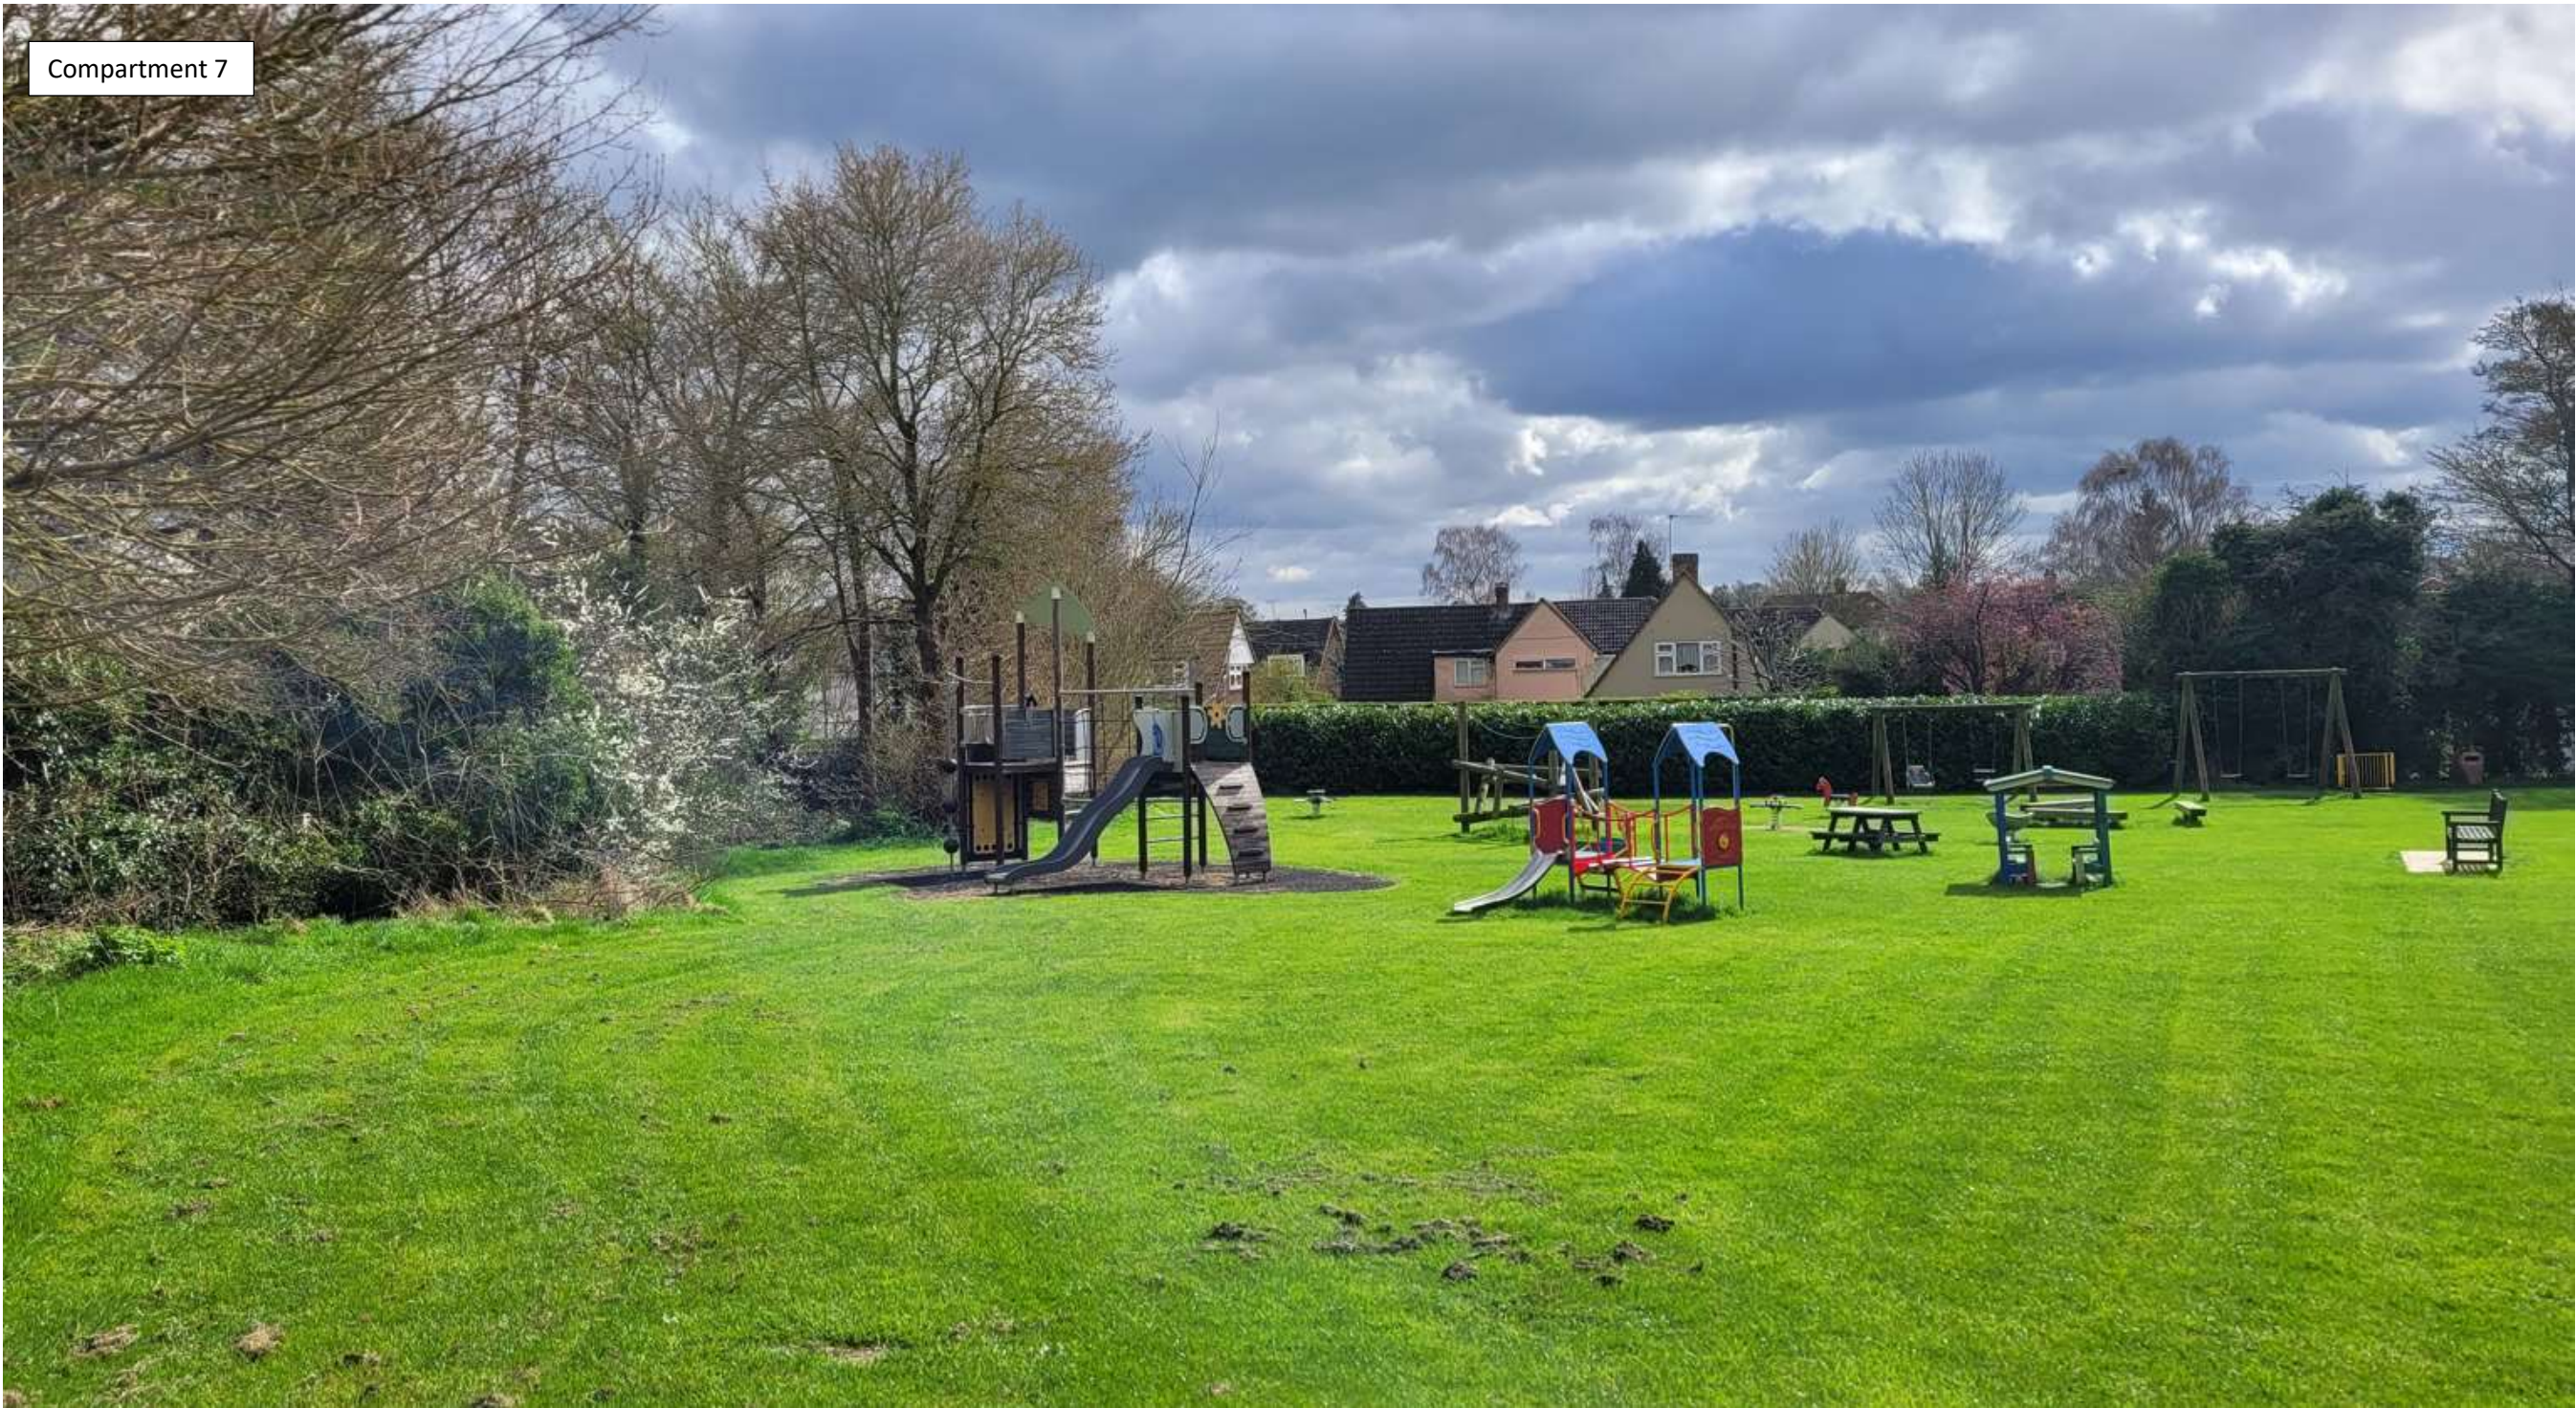
| MAP/ Tag ref | Species | Location | DBH (mm) | Height (m) | Radial crown spread (m) | Age | Crown | Crown break | Stem | Root crown | Rooting area | Overall Condition | Comments | Recommendation(s) | | |
|---|---|---|---|---|---|---|---|---|---|---|---|---|---|---|--|--|
| COMPARTMENT 7 OVERVIEW | No risk associated with land due to tree condition. There are notable issues with the lapsed hedge and shrub adjacent to the waterway, but this is outside of the area of occupation, not considered an arboricultural feature, and away from the play zone. It would be worth considering restricting access to the waterway. | | | | | | | | | | | | | | | |
