**AGENDA**  
for the meeting of the Open Spaces Management Committee

*Report Reference: TS00123\_HATBR\_5888*

*Client: Hatfield Broad Oak Parish Council*

- 1.1 Longacre Tree Surgery consultation services have been asked by the representatives of Hatfield Broadoak Parish Council, to inspect all trees within a designated area. The purpose of this survey is to identify any potential risk associated with the physiological and structural condition of the stock.

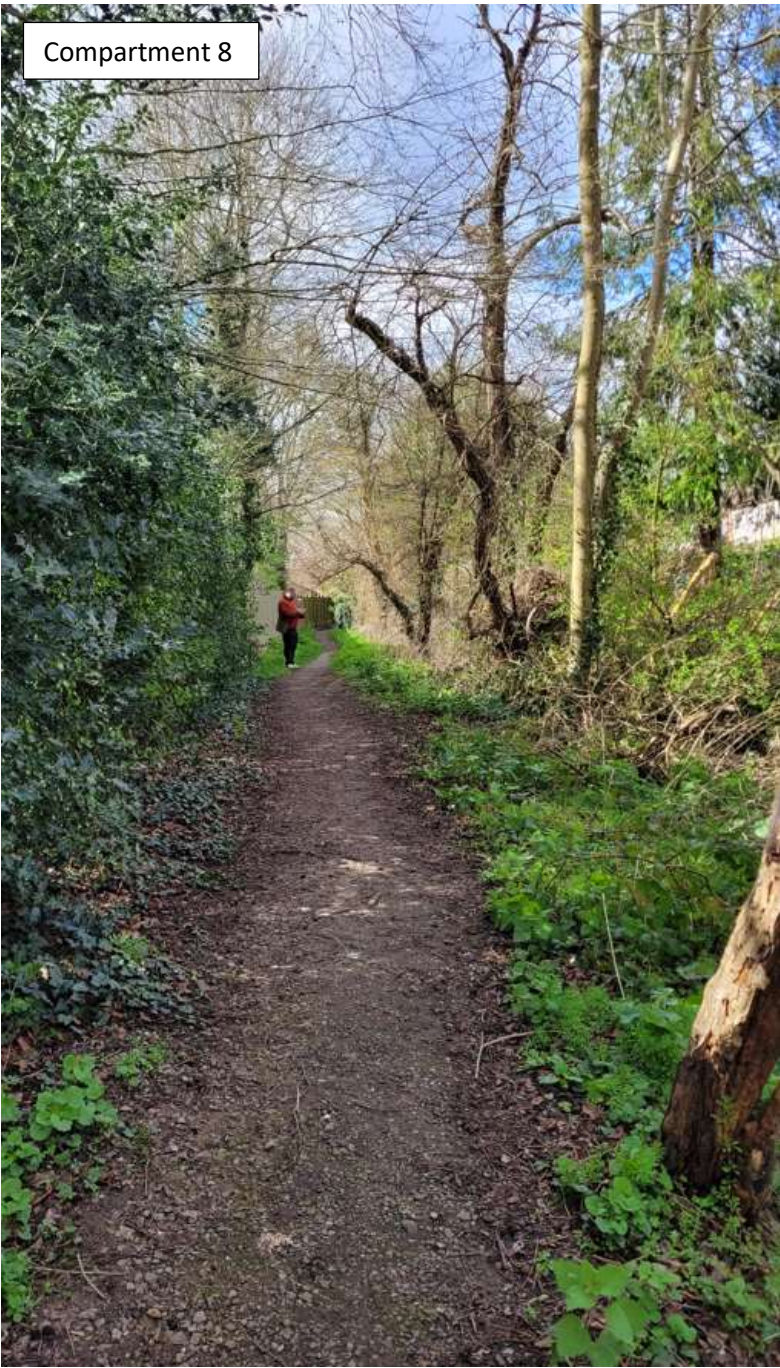
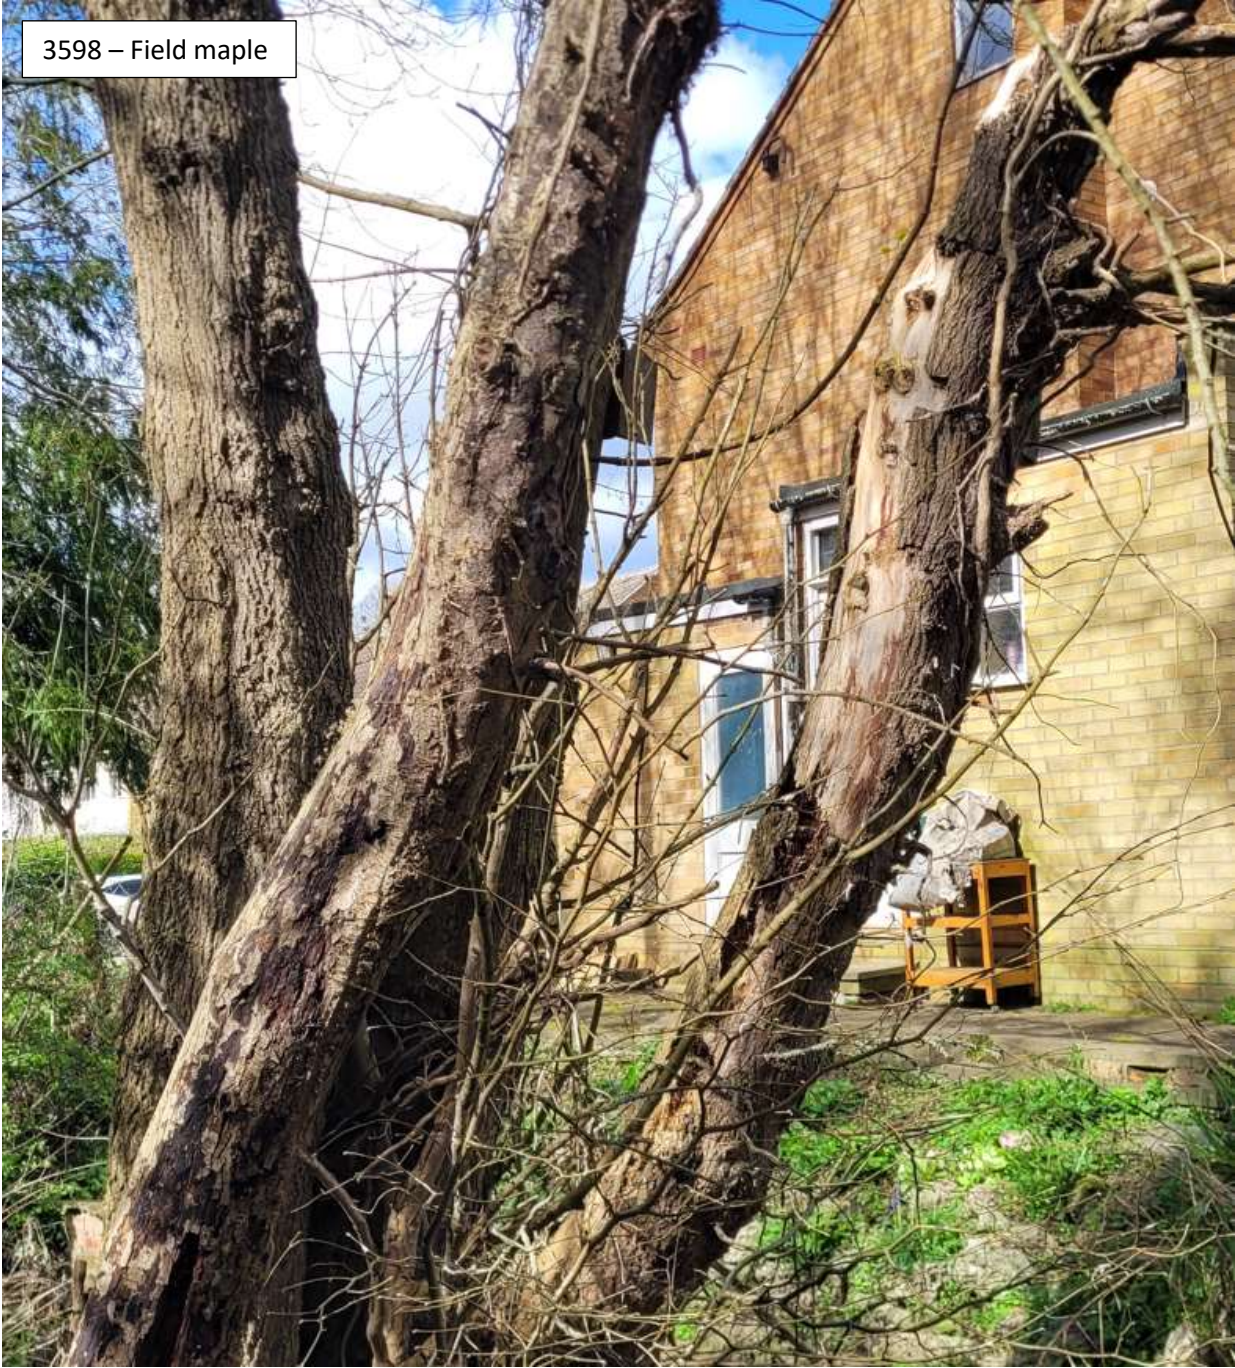
| Tag ref | Map ref | Species | Location | DBH (mm) | Height (m) | Radial crown spread (m) | Age | Crown | Crown break | Stem | Root crown | Rooting area | Overall Condition | Comments | Recommendation(s) | Risk | Priority |
|---|---|---|---|---|---|---|---|---|---|---|---|---|---|---|---|---|---|
| 3598 | 42 | Maple | G8 adjacent to no.12 | 100 | 8 | 8 | | Poor | Poor | twin stem | Poor | Poor | Poor | Leaning | Fell | | 2 |
| 3555 | 45 | Ash | G8 adj Brook Hse | 840 | 12 | 10 | | Good | Good | Good | Good | Good | Good | Proximity to property | Reduce to historic points of reduction | | 3 |
| COMPARTMENT 8 OVERVIEW | Stressed and dead trees within the grass area adjacent to the waterway. Works is required to mitigate the risk of collapse which could cause injury to person or property or restrict access | | | | | | | | | | | | | | | | |
