## AGENDA for the meeting of the Open Spaces Management Committee

# Safety Inspection Report

## Water Inspection

Site name: **Pond**  
Date of inspection: **24 May 2024**  
Inspector: **Lewis Heath**

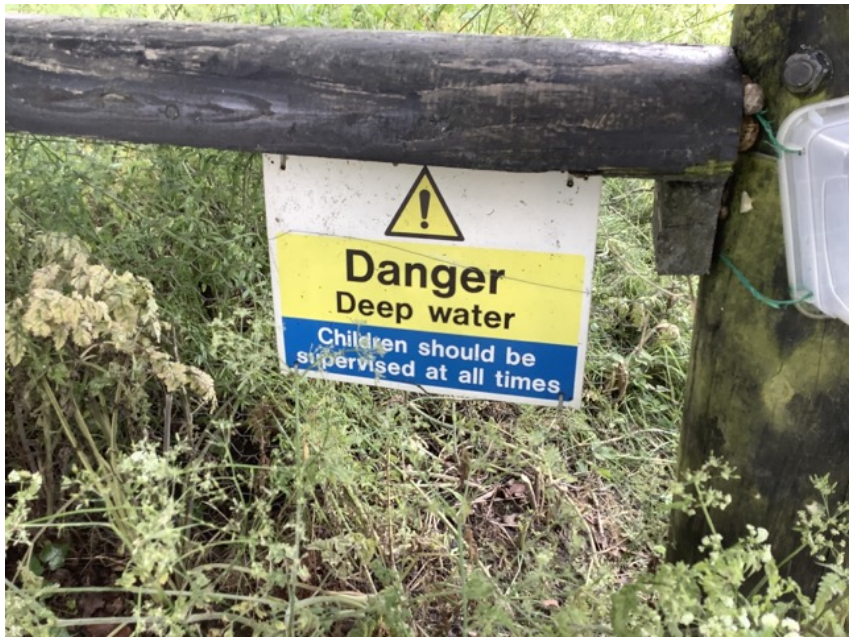
# Signage - Warning - Deep Water

One sign at roadside gate only. Recommended that additional signs are added along pond fencing so that is visible from all sides.

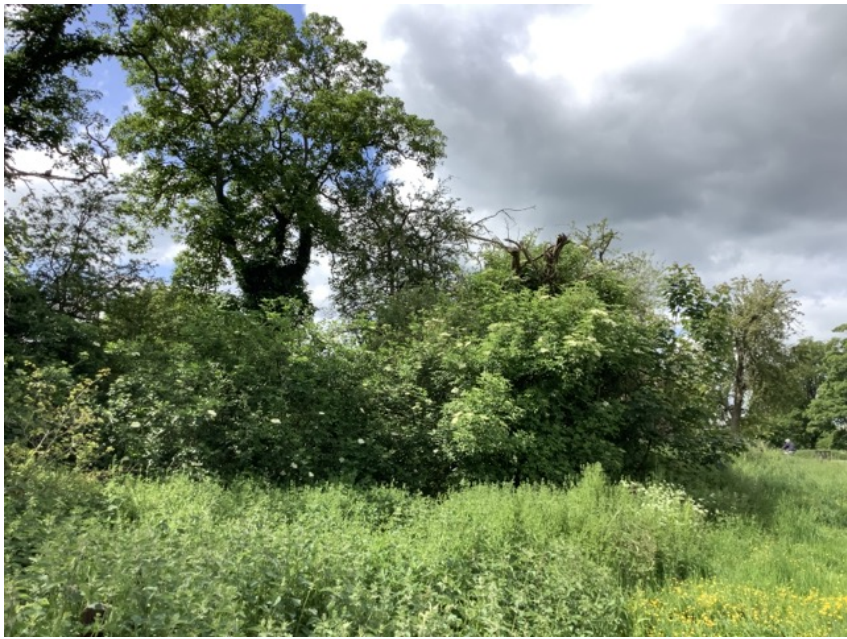
# Planting

Planting area is overgrown around the perimeter of the pond and is difficult to see where the pond edge starts and where ground is solid. There are also steep banks leading to the pond. Recommend the area is thinned out and area around the pond is clearly made visible to users of the park/pond.

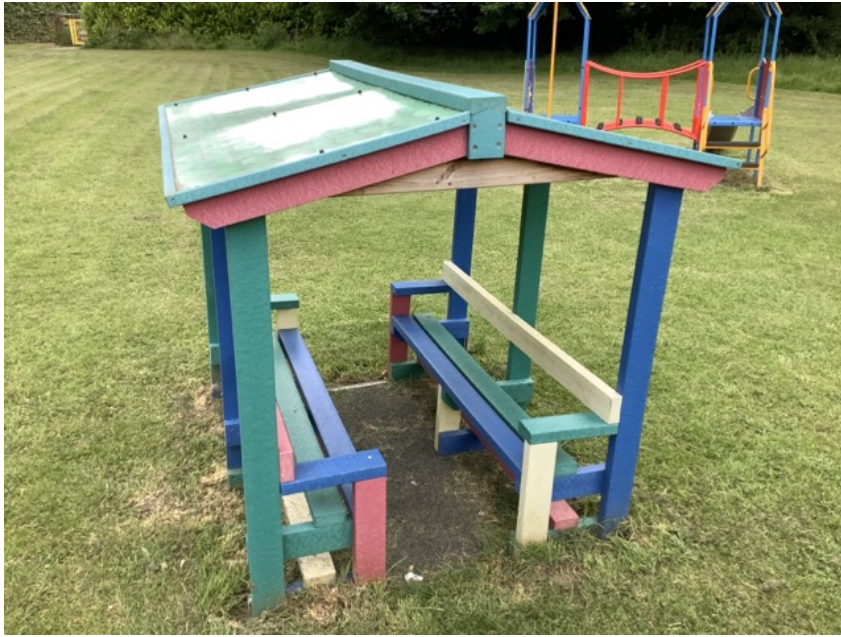
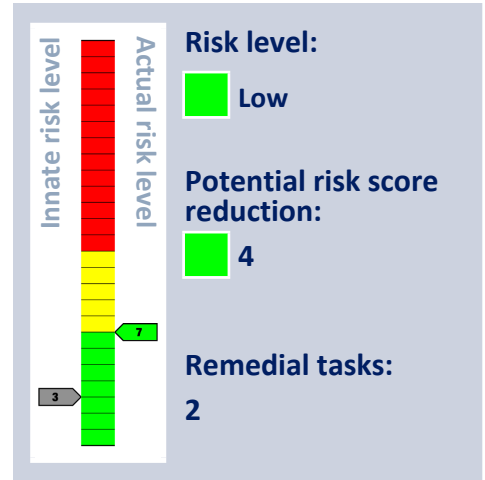
Bolt(s) loose.

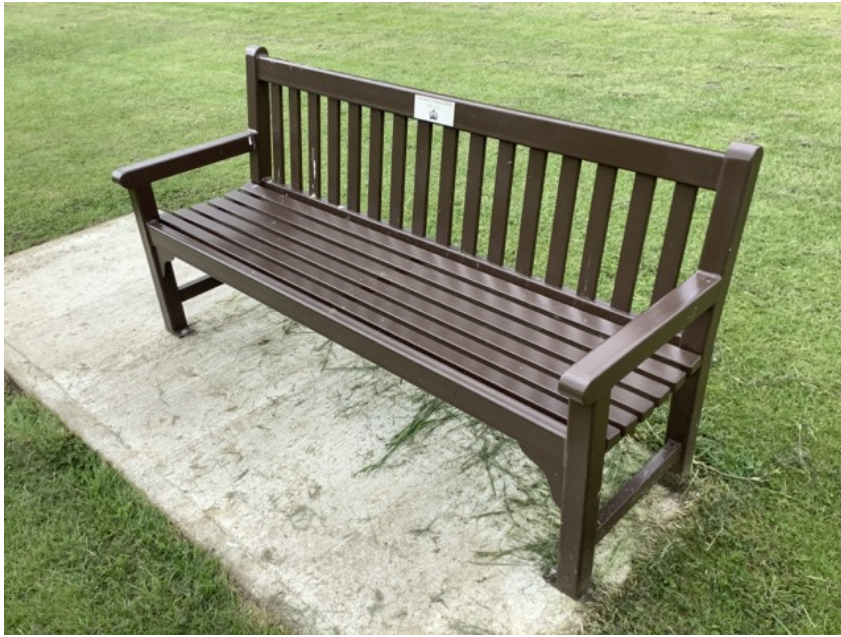
Trip points on the surface.

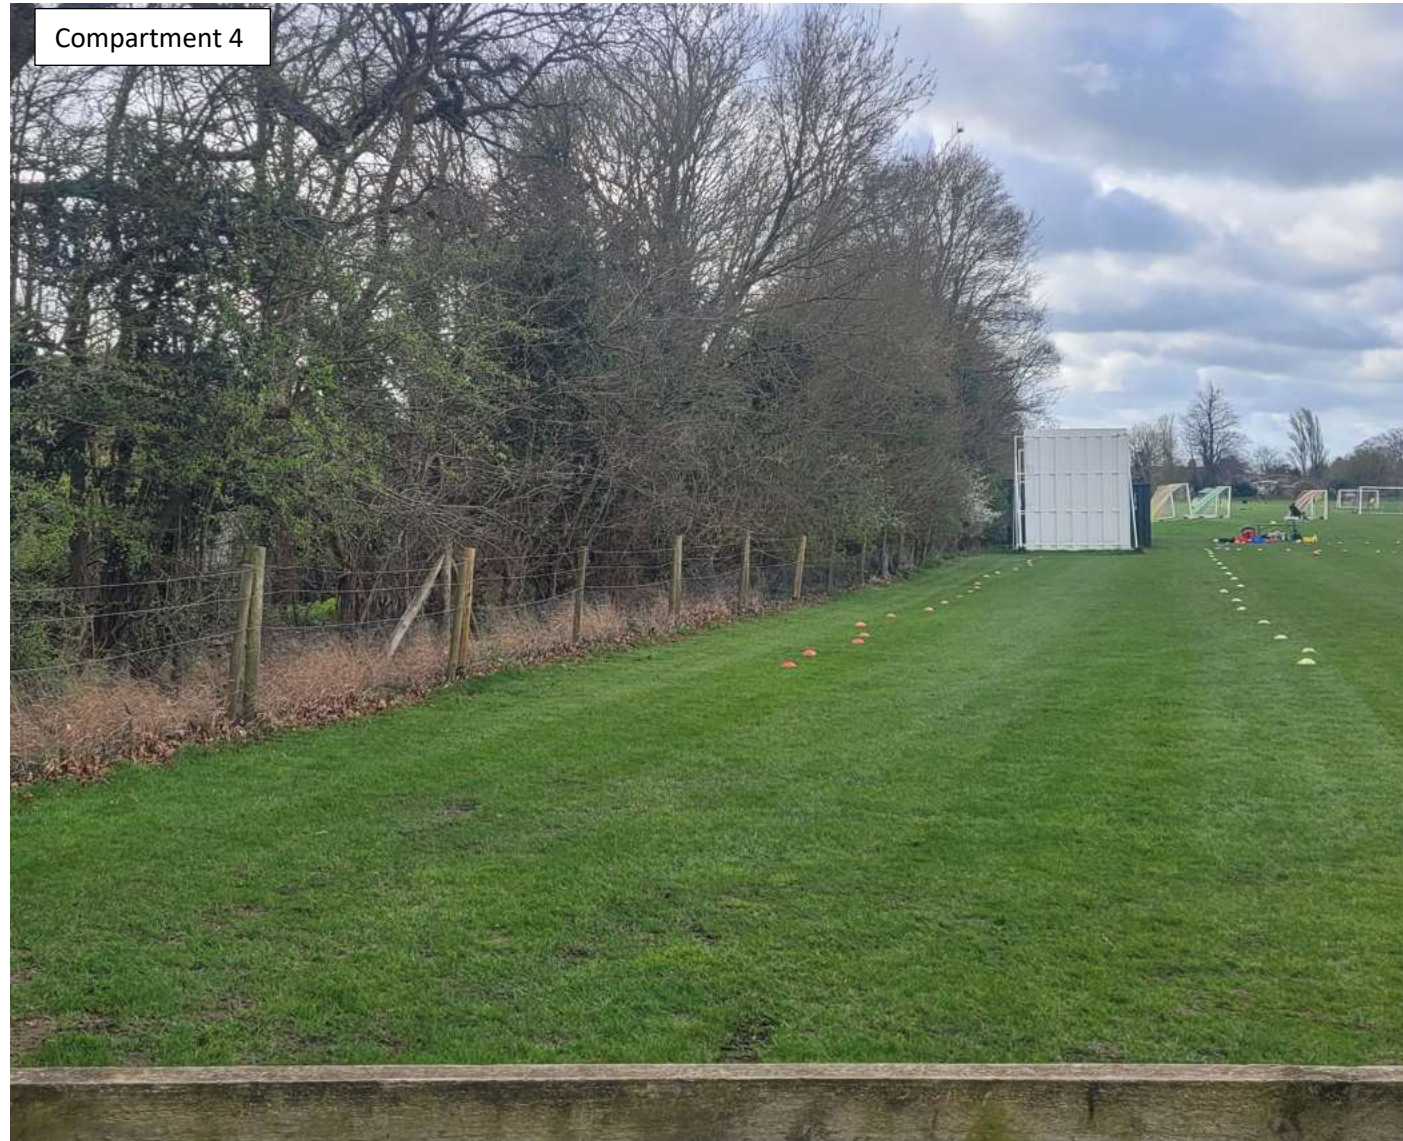
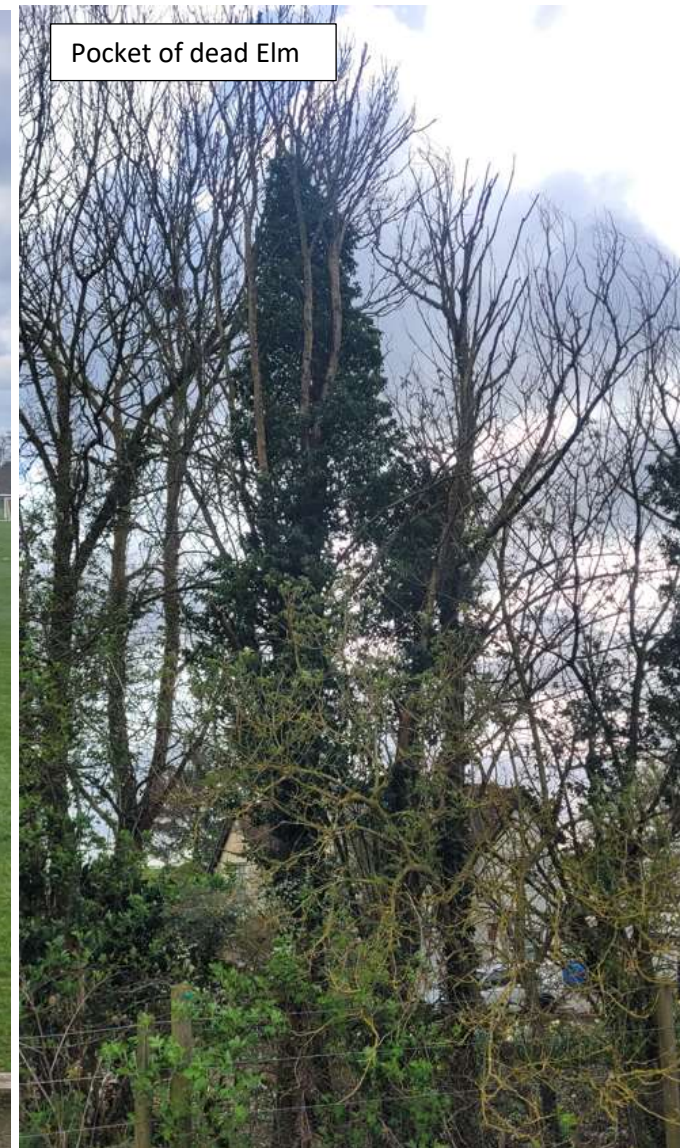
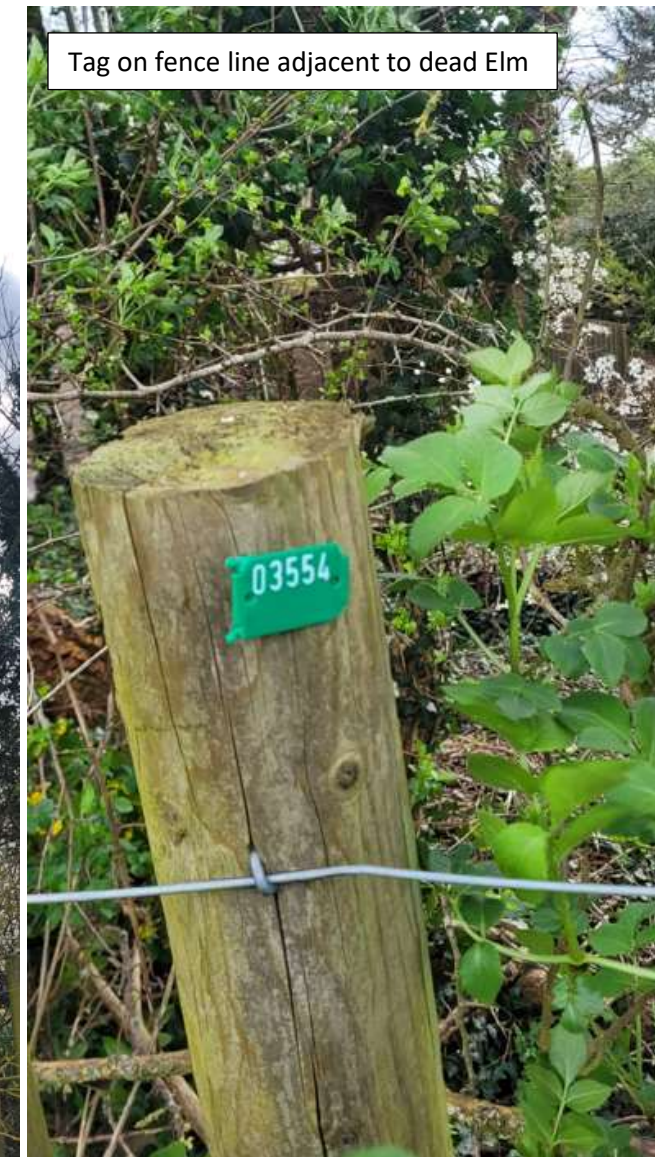
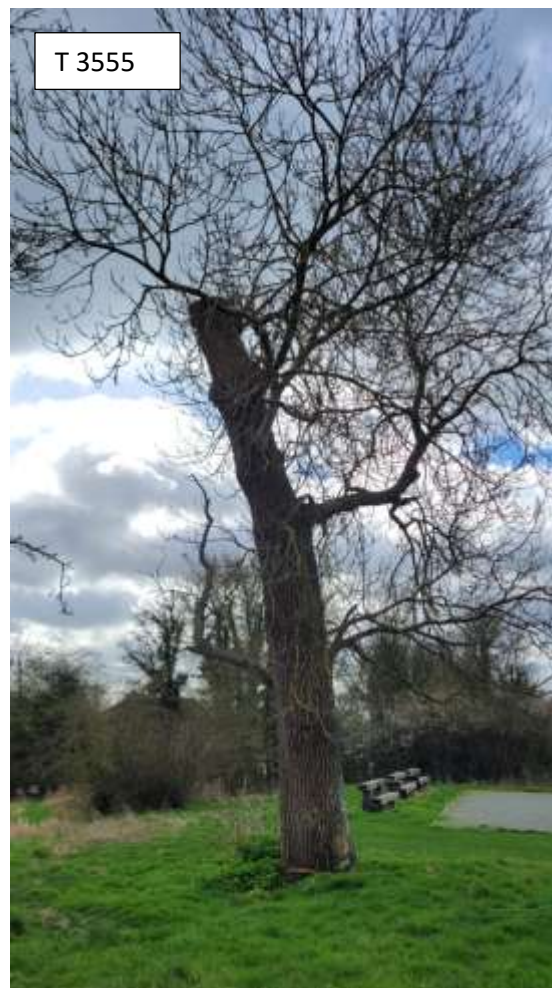
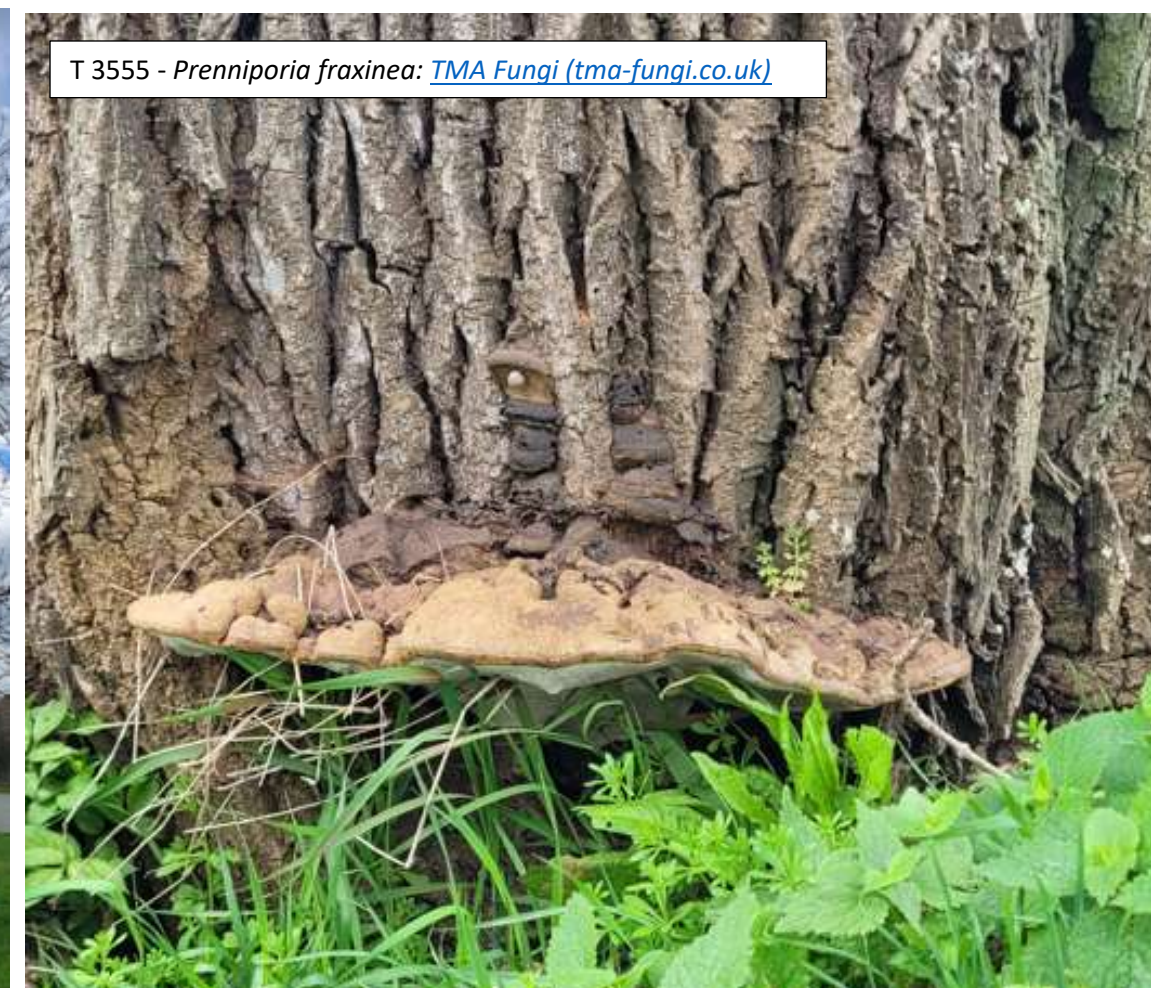
| Tag ref | Map ref | Species | Location | DBH (mm) | Height (m) | Radial crown spread (m) | Age | Crown | Crown break | Stem | Root crown | Rooting area | Overall Condition | Comments | Recommendation(s) | Risk | Priority |
|---|---|---|---|---|---|---|---|---|---|---|---|---|---|---|---|---|---|
| COMPARTMENT 4 OVERVIEW | No risk associated with area apart from pocket of dead elm adjacent to fence line. Ecological areas are closed off to public. | | | | | | | | | | | | | | | | |

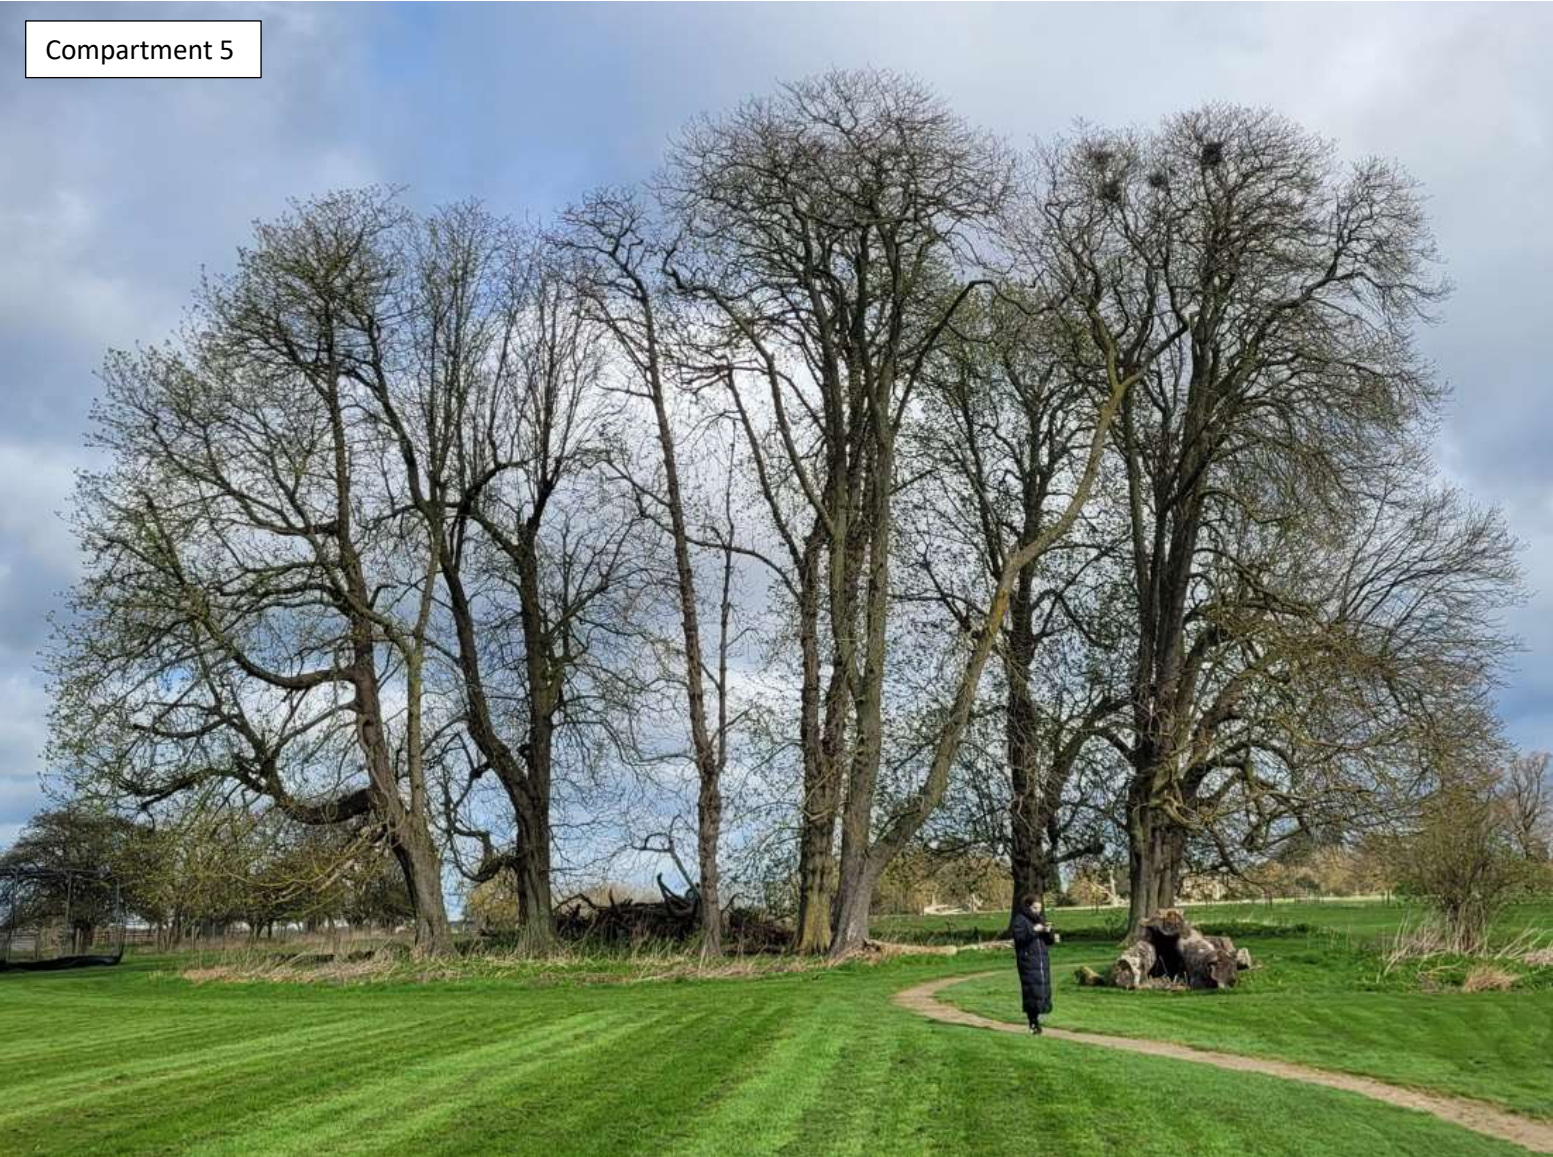
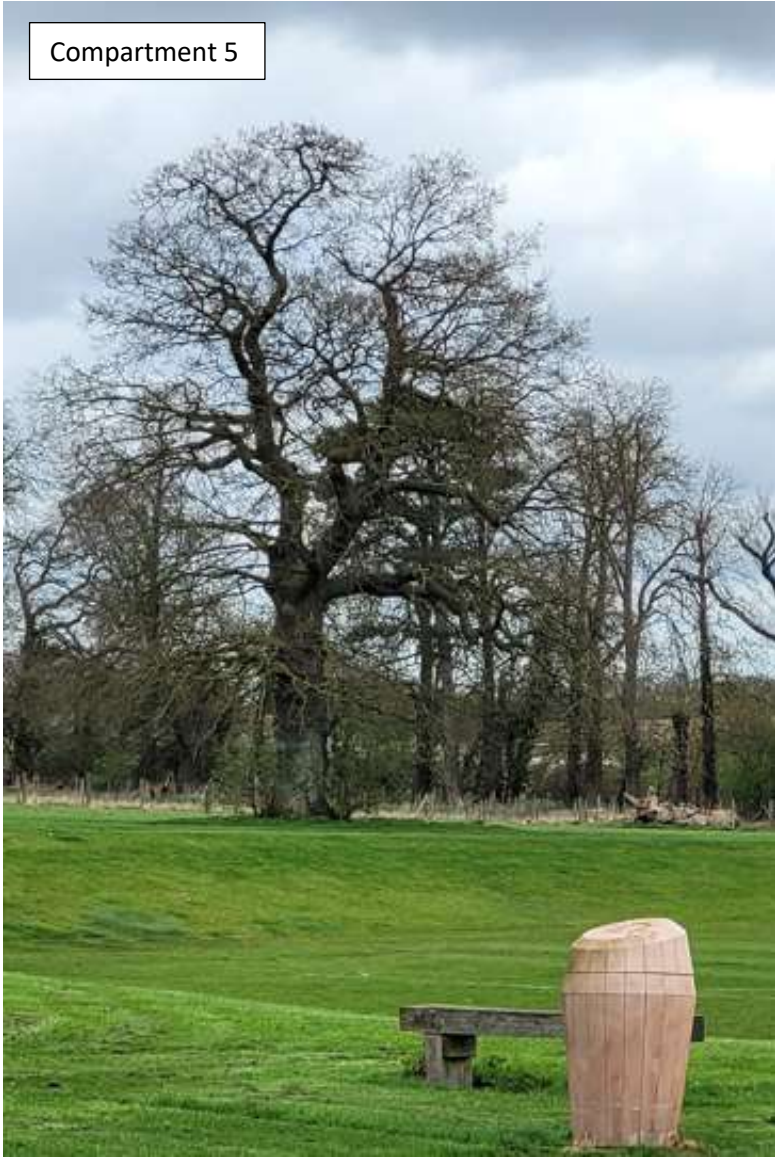
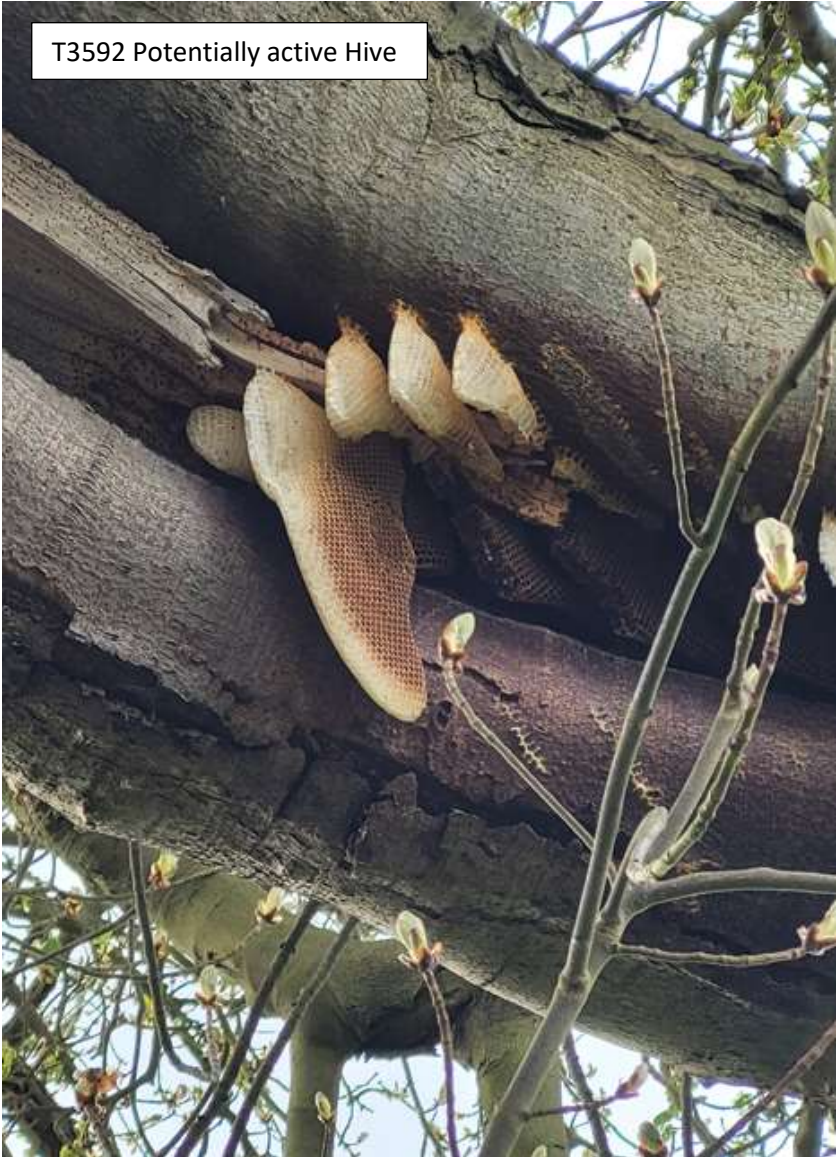
| COMPARTMENT 5 OVERVIEW | Chestnuts in varying conditions. Active nest and potentially active hive. Although within an area of low occupancy, the risk level of this compartment is elevated moderate which requires works to mitigate to an acceptable level, <b>due to the zone being an area of congregation within an area of low occupancy</b> | | | | | | | | | | | | | | | | |

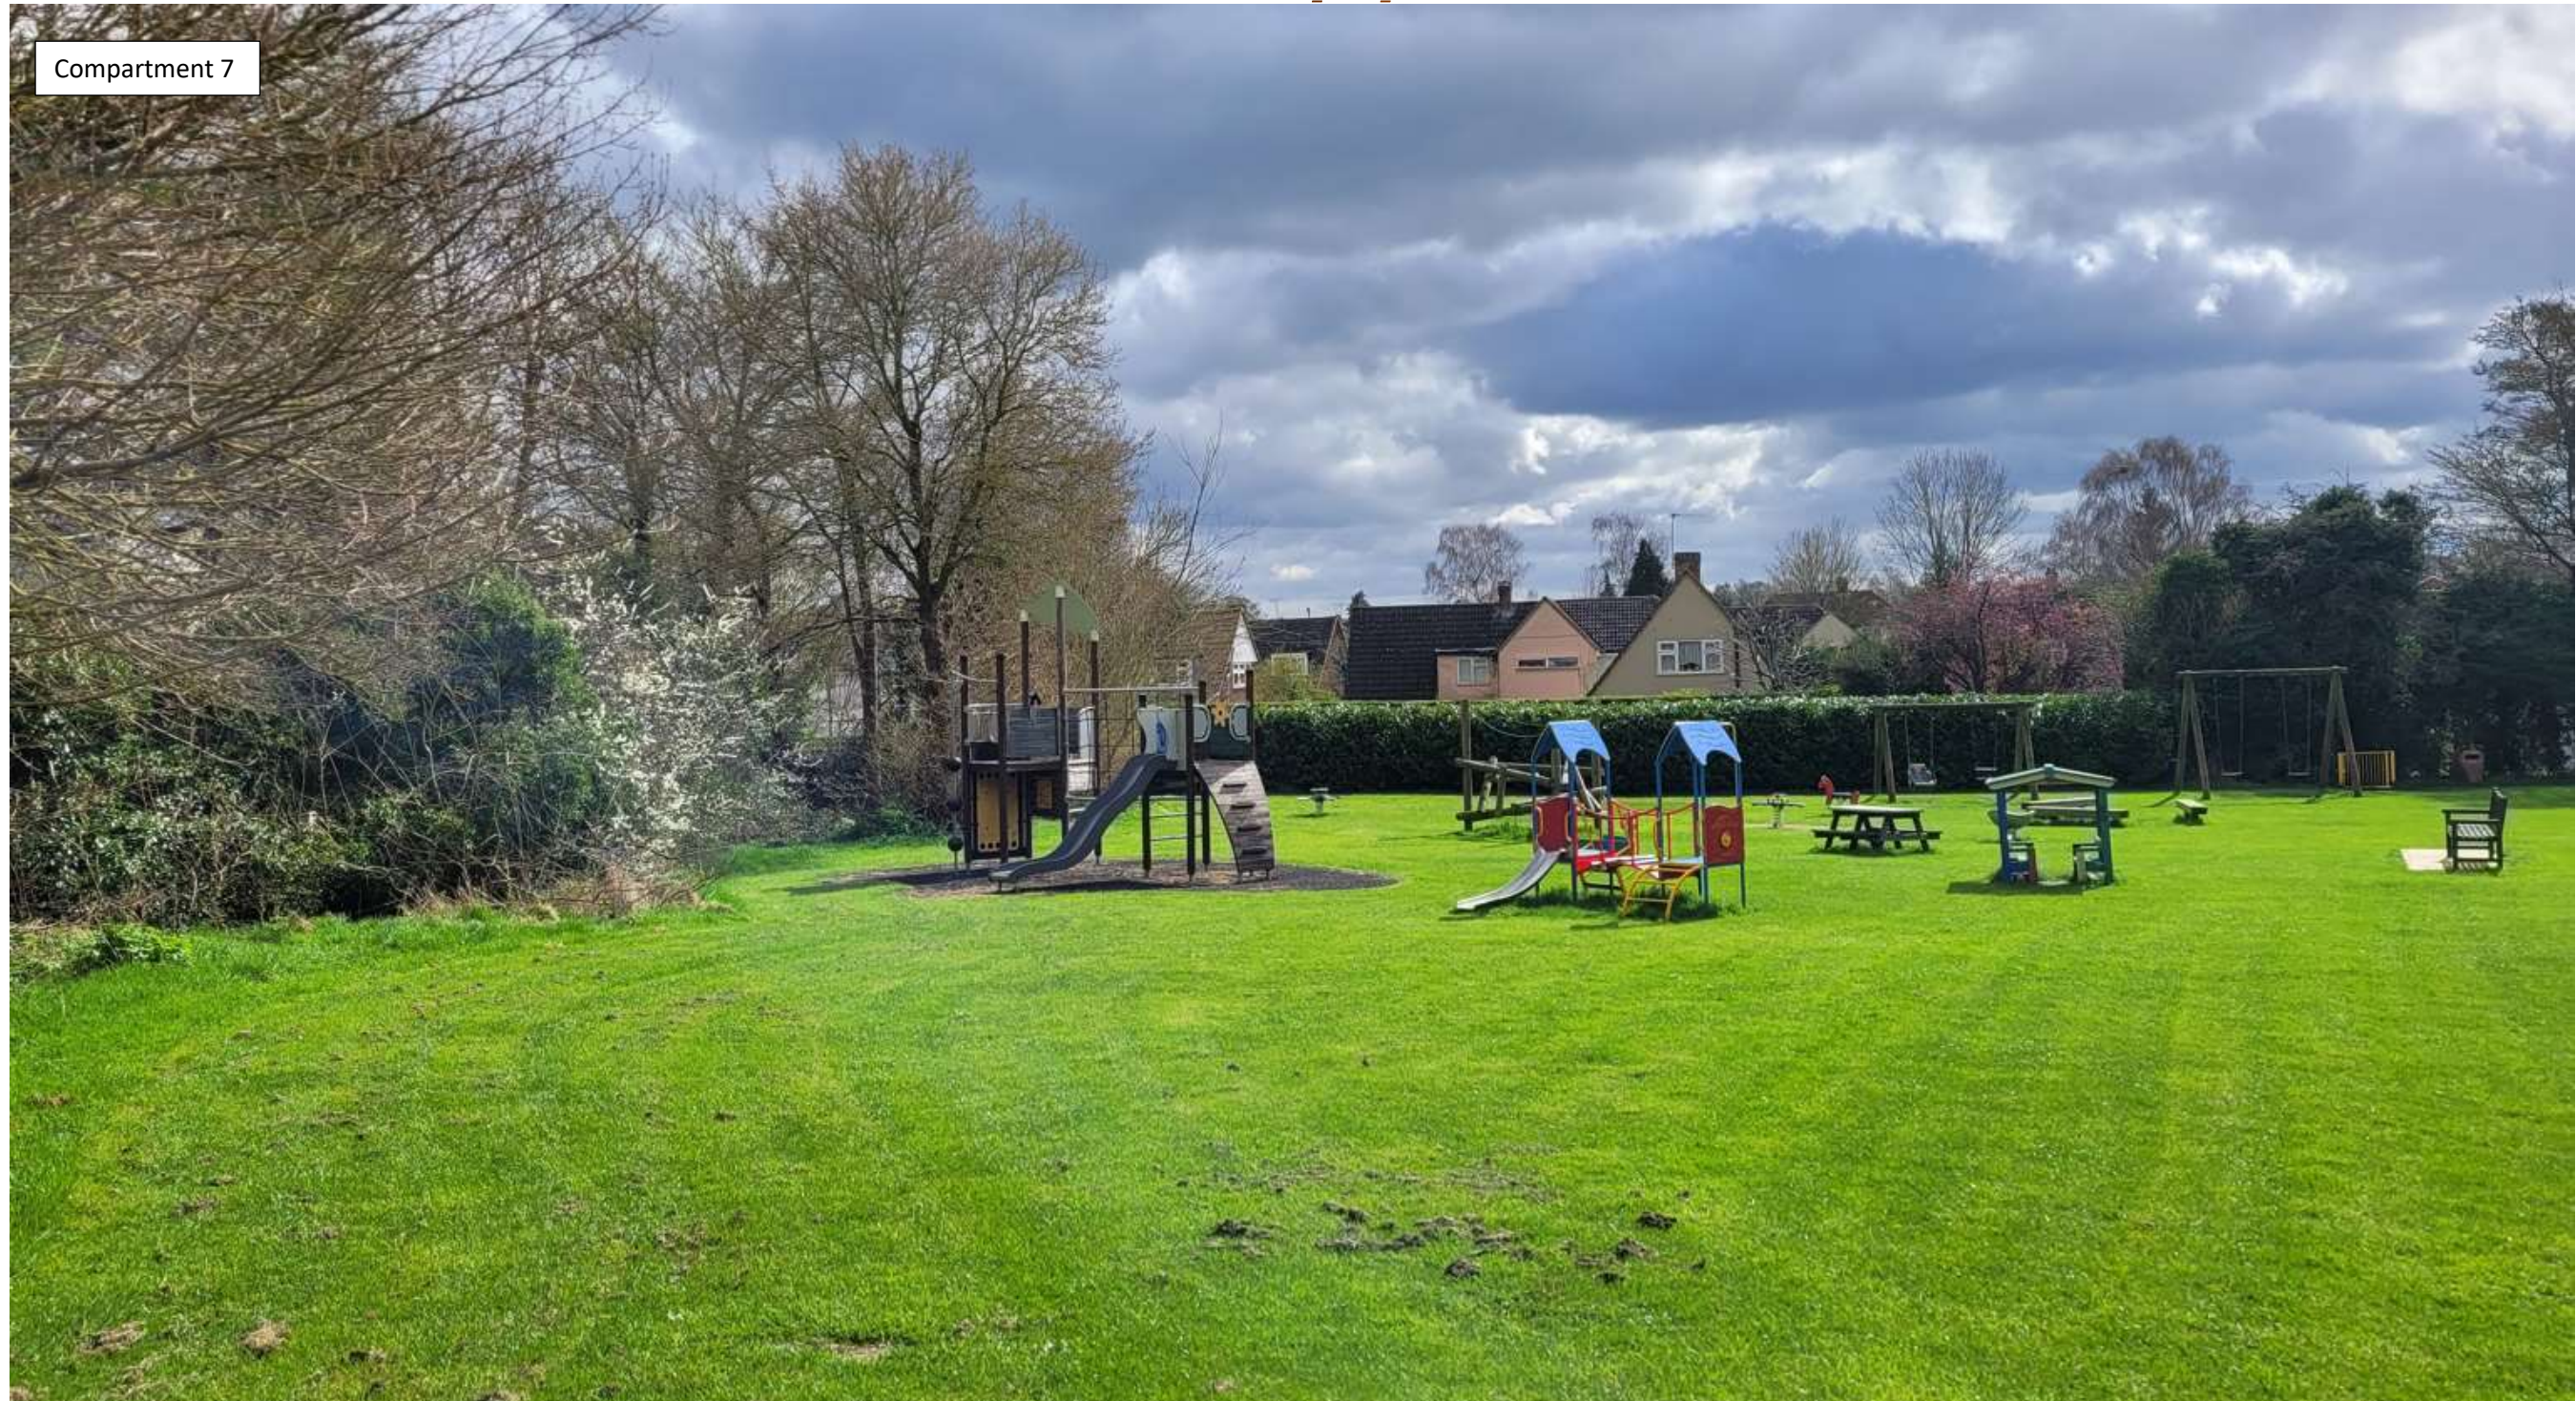
Compartment 7

| MAP/ Tag ref | Species | Location | DBH (mm) | Height (m) | Radial crown spread (m) | Age | Crown | Crown break | Stem | Root crown | Rooting area | Overall Condition | Comments | Recommendation(s) | | |
|---|---|---|---|---|---|---|---|---|---|---|---|---|---|---|--|--|
| COMPARTMENT 7 OVERVIEW | No risk associated with land due to tree condition. There are notable issues with the lapsed hedge and shrub adjacent to the waterway, but this is outside of the area of occupation, not considered an arboricultural feature, and away from the play zone. It would be worth considering restricting access to the waterway. | | | | | | | | | | | | | | | |

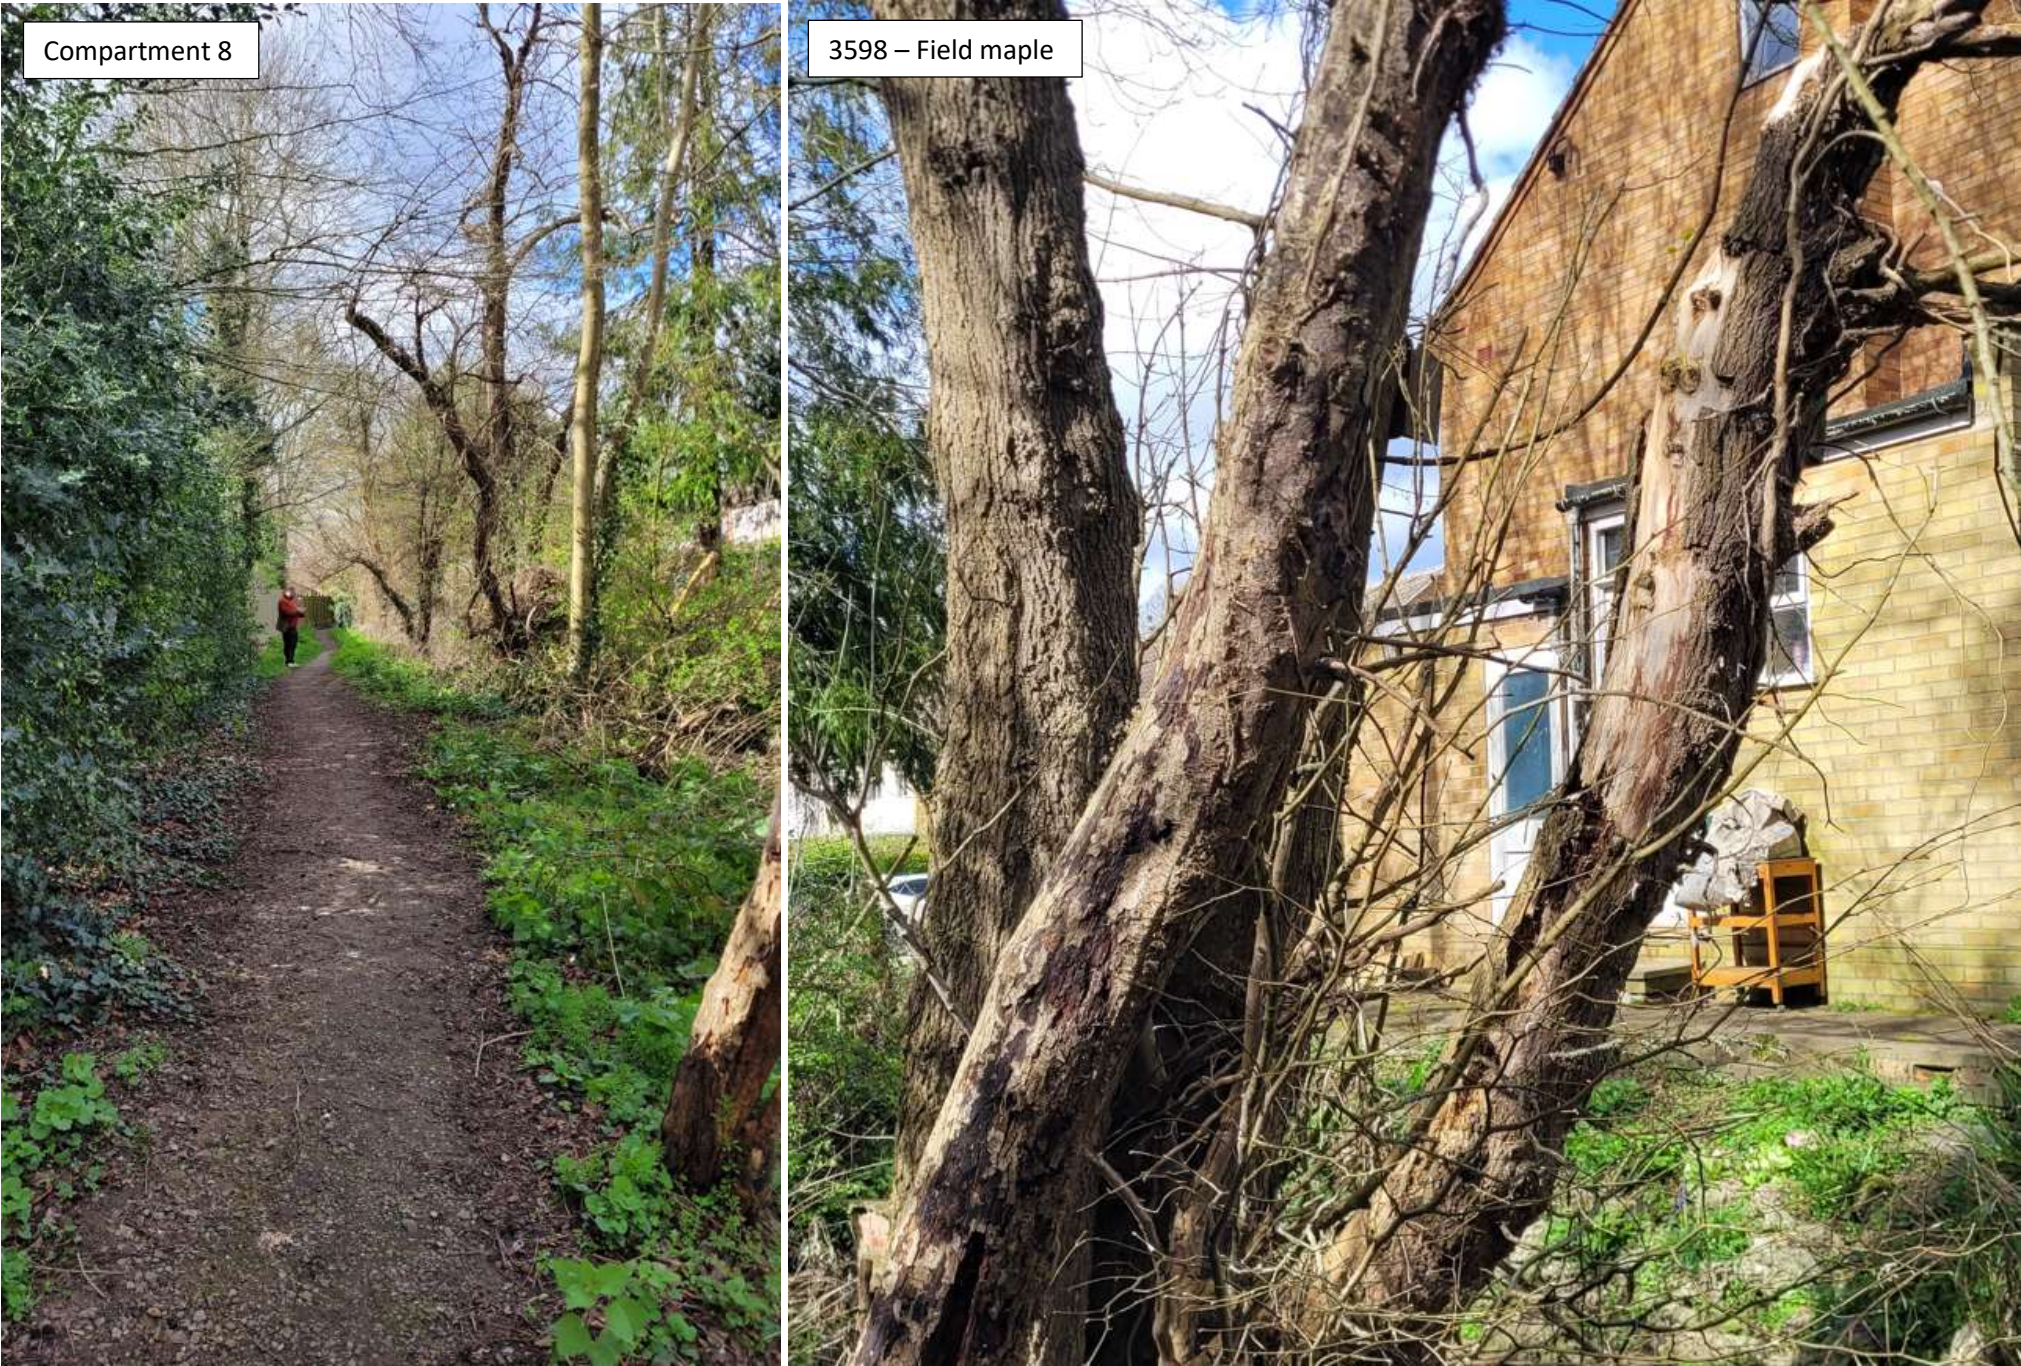
| TS00123_HATBR_5888 | | | | | | | | | | | | | | | | | |
|---|---|---|---|---|---|---|---|---|---|---|---|---|---|---|---|---|---|
| COMPARTMENT 8 OVERVIEW | Stressed and dead trees within the grass area adjacent to the waterway. Works is required to mitigate the risk of collapse which could cause injury to person or property or restrict access | | | | | | | | | | | | | | | | |
