**AGENDA**  
for the meeting of the Open Spaces Management Committee

*Report Reference: TS00123\_HATBR\_5888*

*Client: Hatfield Broad Oak Parish Council*

- 1.1 Longacre Tree Surgery consultation services have been asked by the representatives of Hatfield Broadoak Parish Council, to inspect all trees within a designated area. The purpose of this survey is to identify any potential risk associated with the physiological and structural condition of the stock.

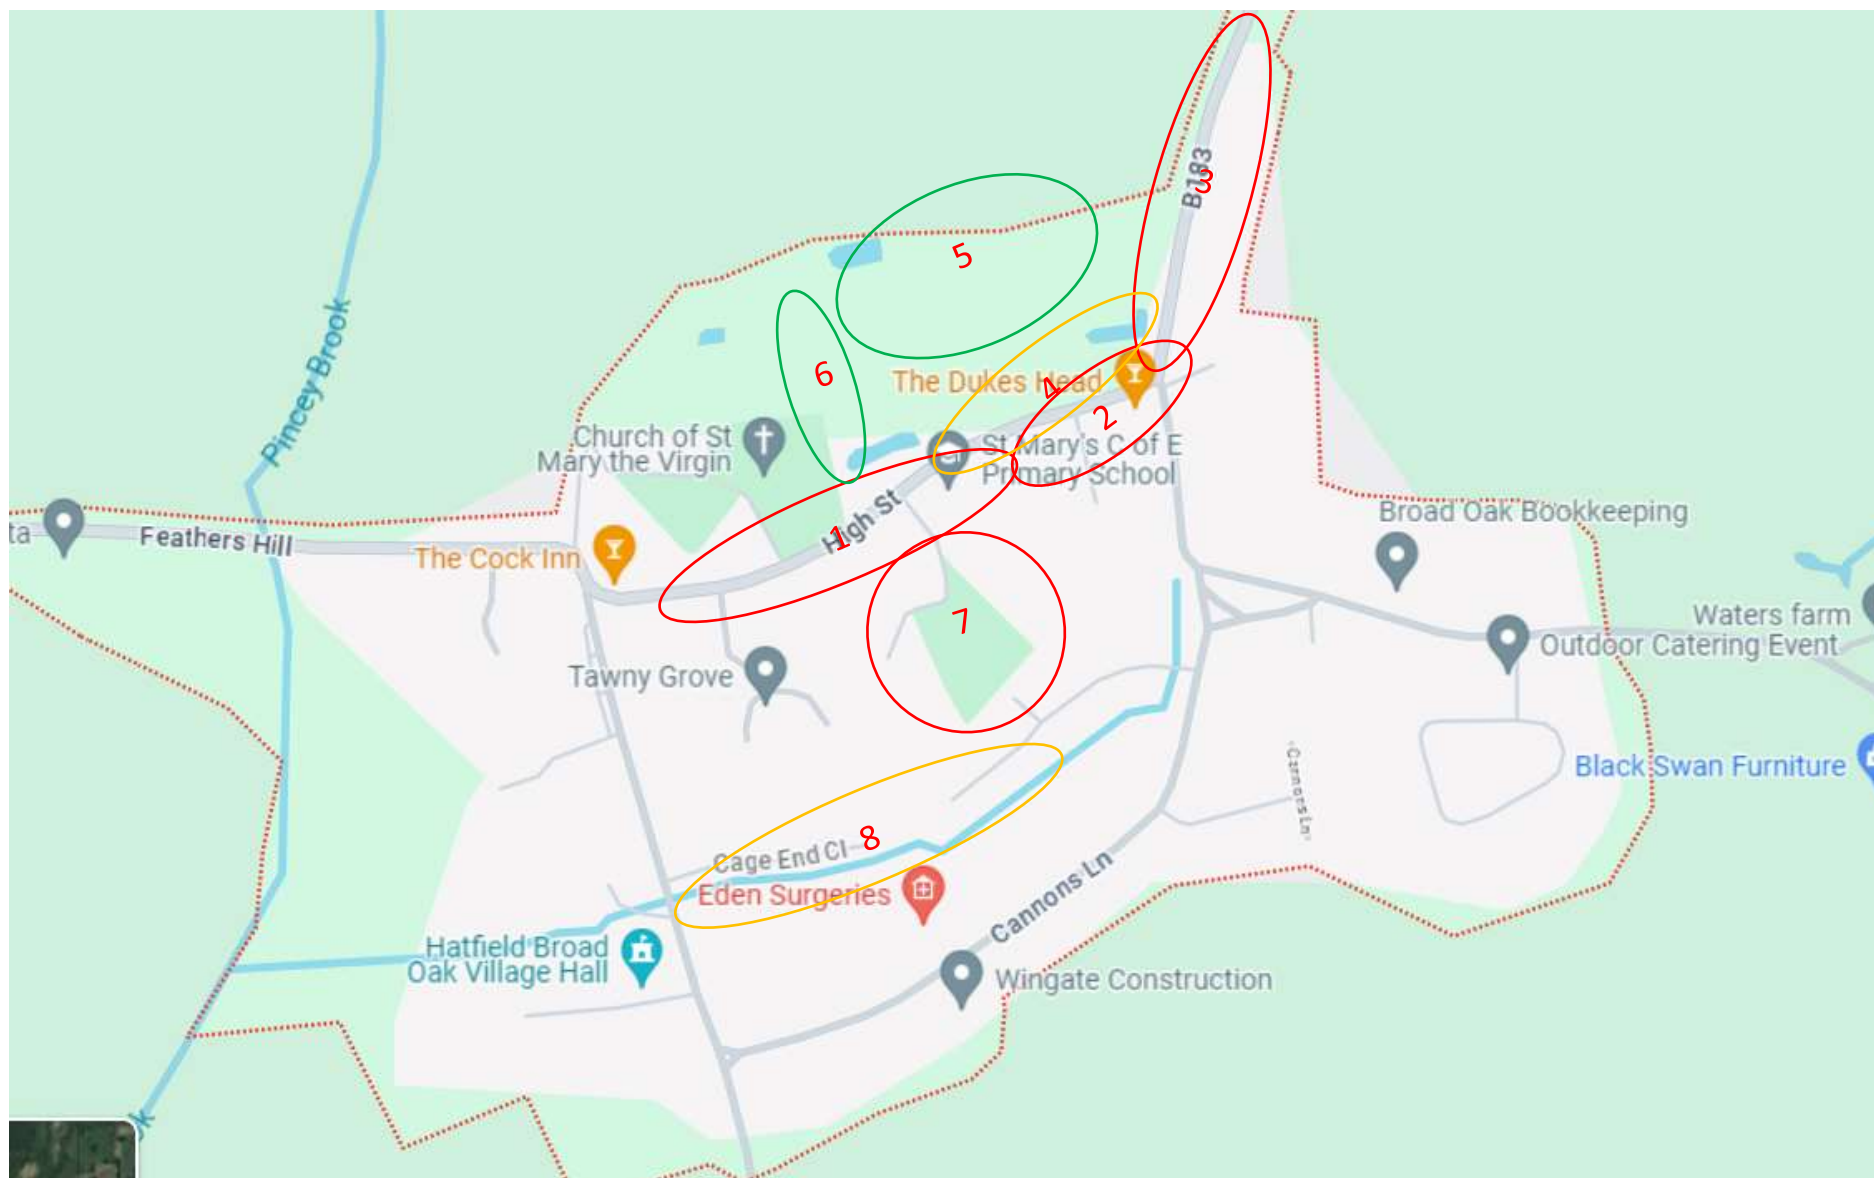
- 1.3 The areas that have been highlighted for survey have been broken down into compartments from 1 to 8:

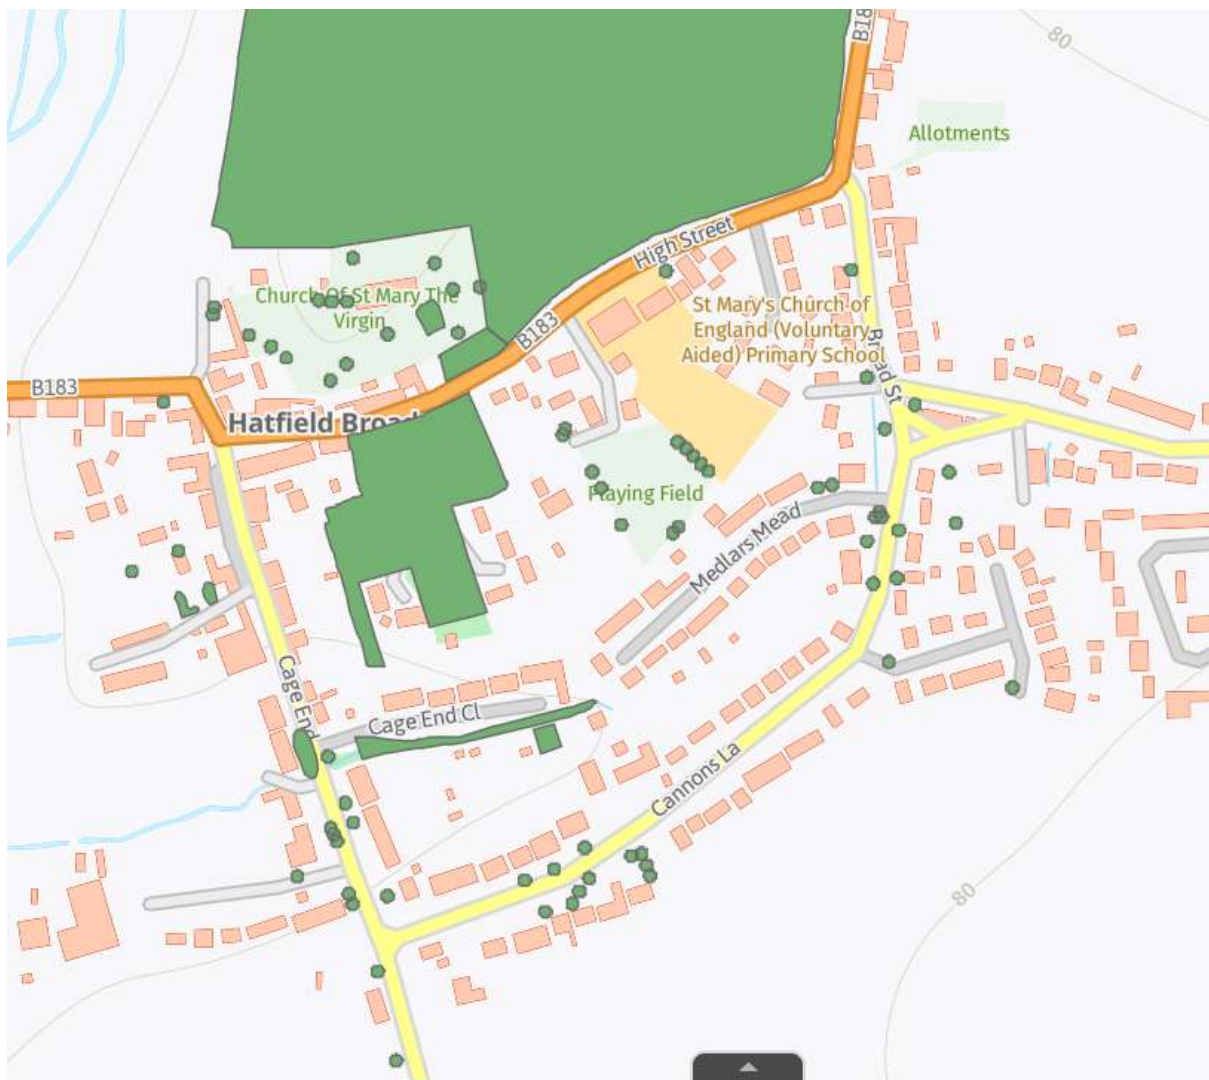
- 3.4 Tree preservation orders and group preservation orders are prevalent (green areas within the map below), covering trees within compartment 1, 2, 3, 4, 5, 6, 7 and 8. Notably there is a gap between the Highstreet (B183) and TPO reference 2/76/55 which is the most northern group TPO on the map. This may mean that the trees within compartments 1 and 2 are not governed by this preservation order, but this would need to be qualified by the respective Local Planning Authority. Trees within all other compartments are under preservation and as such require local authority consent before works can commence.

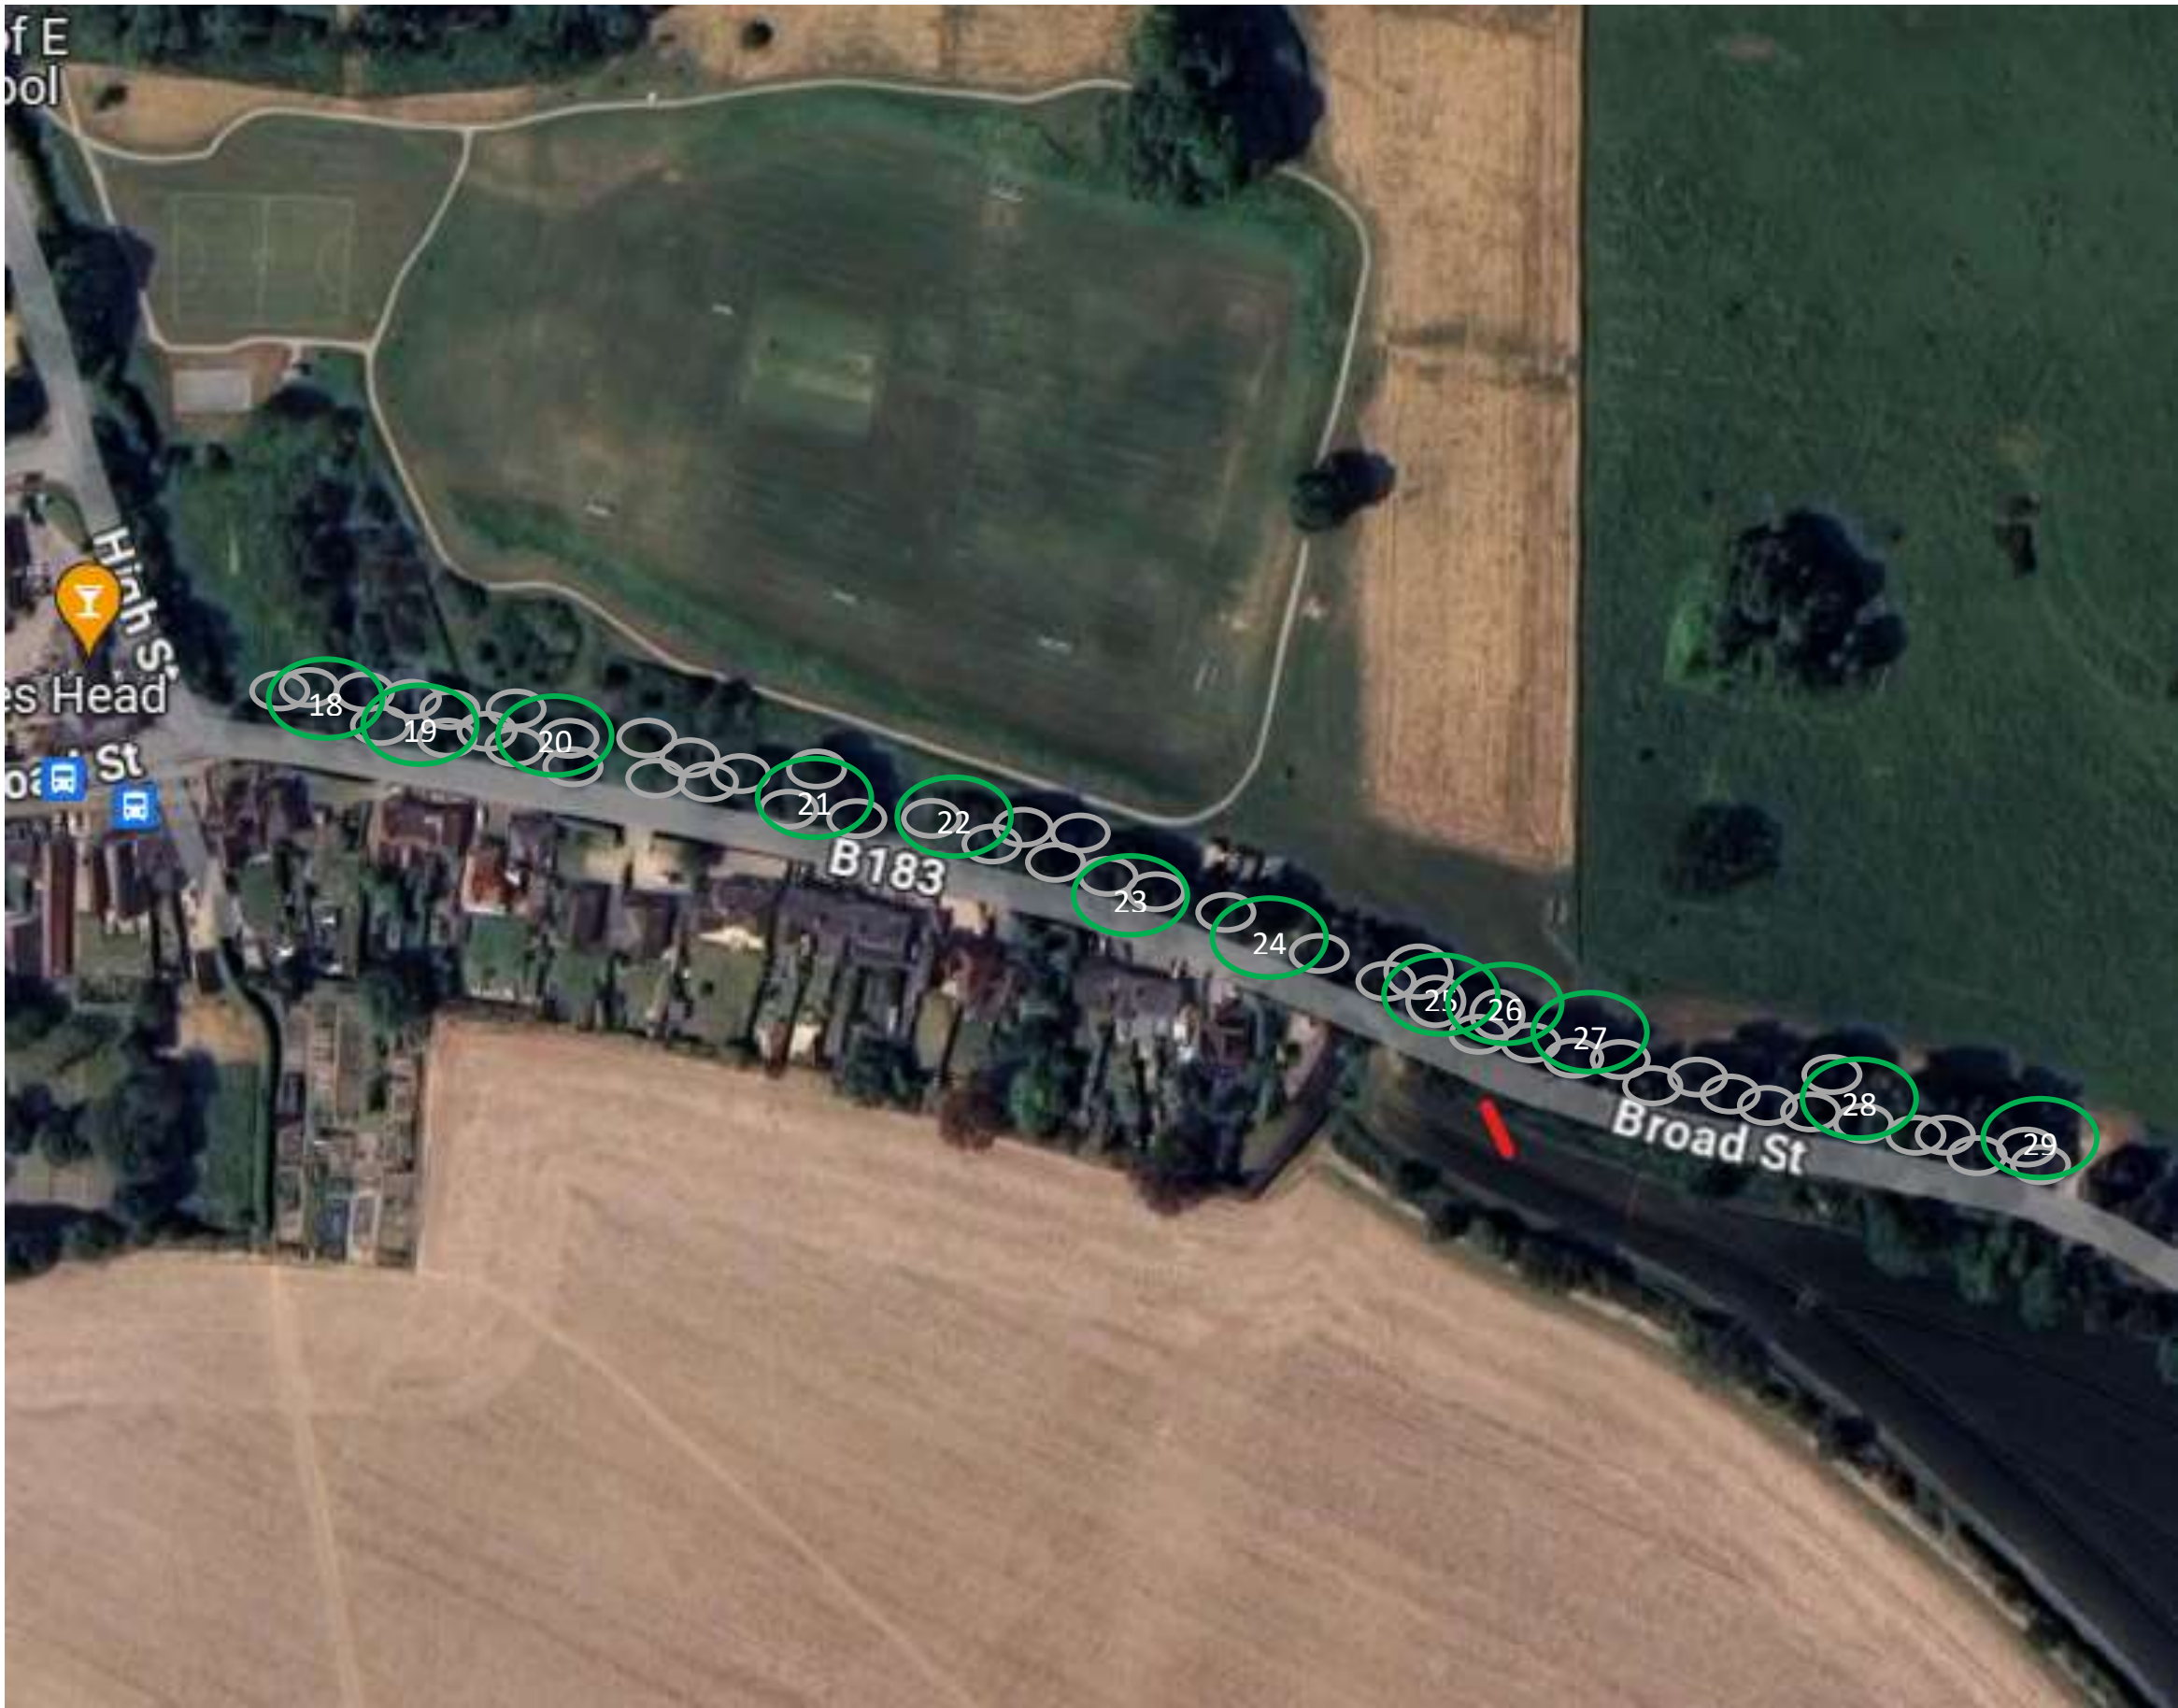
| Tag ref | Map ref | Species | Location | DBH (mm) | Height (m) | Radial crown spread (m) | Age | Crown | Crown break | Stem | Root crown | Rooting area | Overall Condition | Comments | Recommendation(s) | Risk | Priority |
|---|---|---|---|---|---|---|---|---|---|---|---|---|---|---|---|---|---|
| COMPARTMENT 3 OVERVIEW | Sooty bark present within stock this will require monitoring of the Sycamore on an annual basis to gauge the progression. Low growth over road will be a restriction to high sided vehicles sometime within the next 12 month. Flail works apparent but not to extra heavy vehicle height. Group of Horse chestnut found to be in poor condition. Collapse of these would potentially be onto the public carriageway, mitigation works, and annual monitoring required. | | | | | | | | | | | | | | | | |

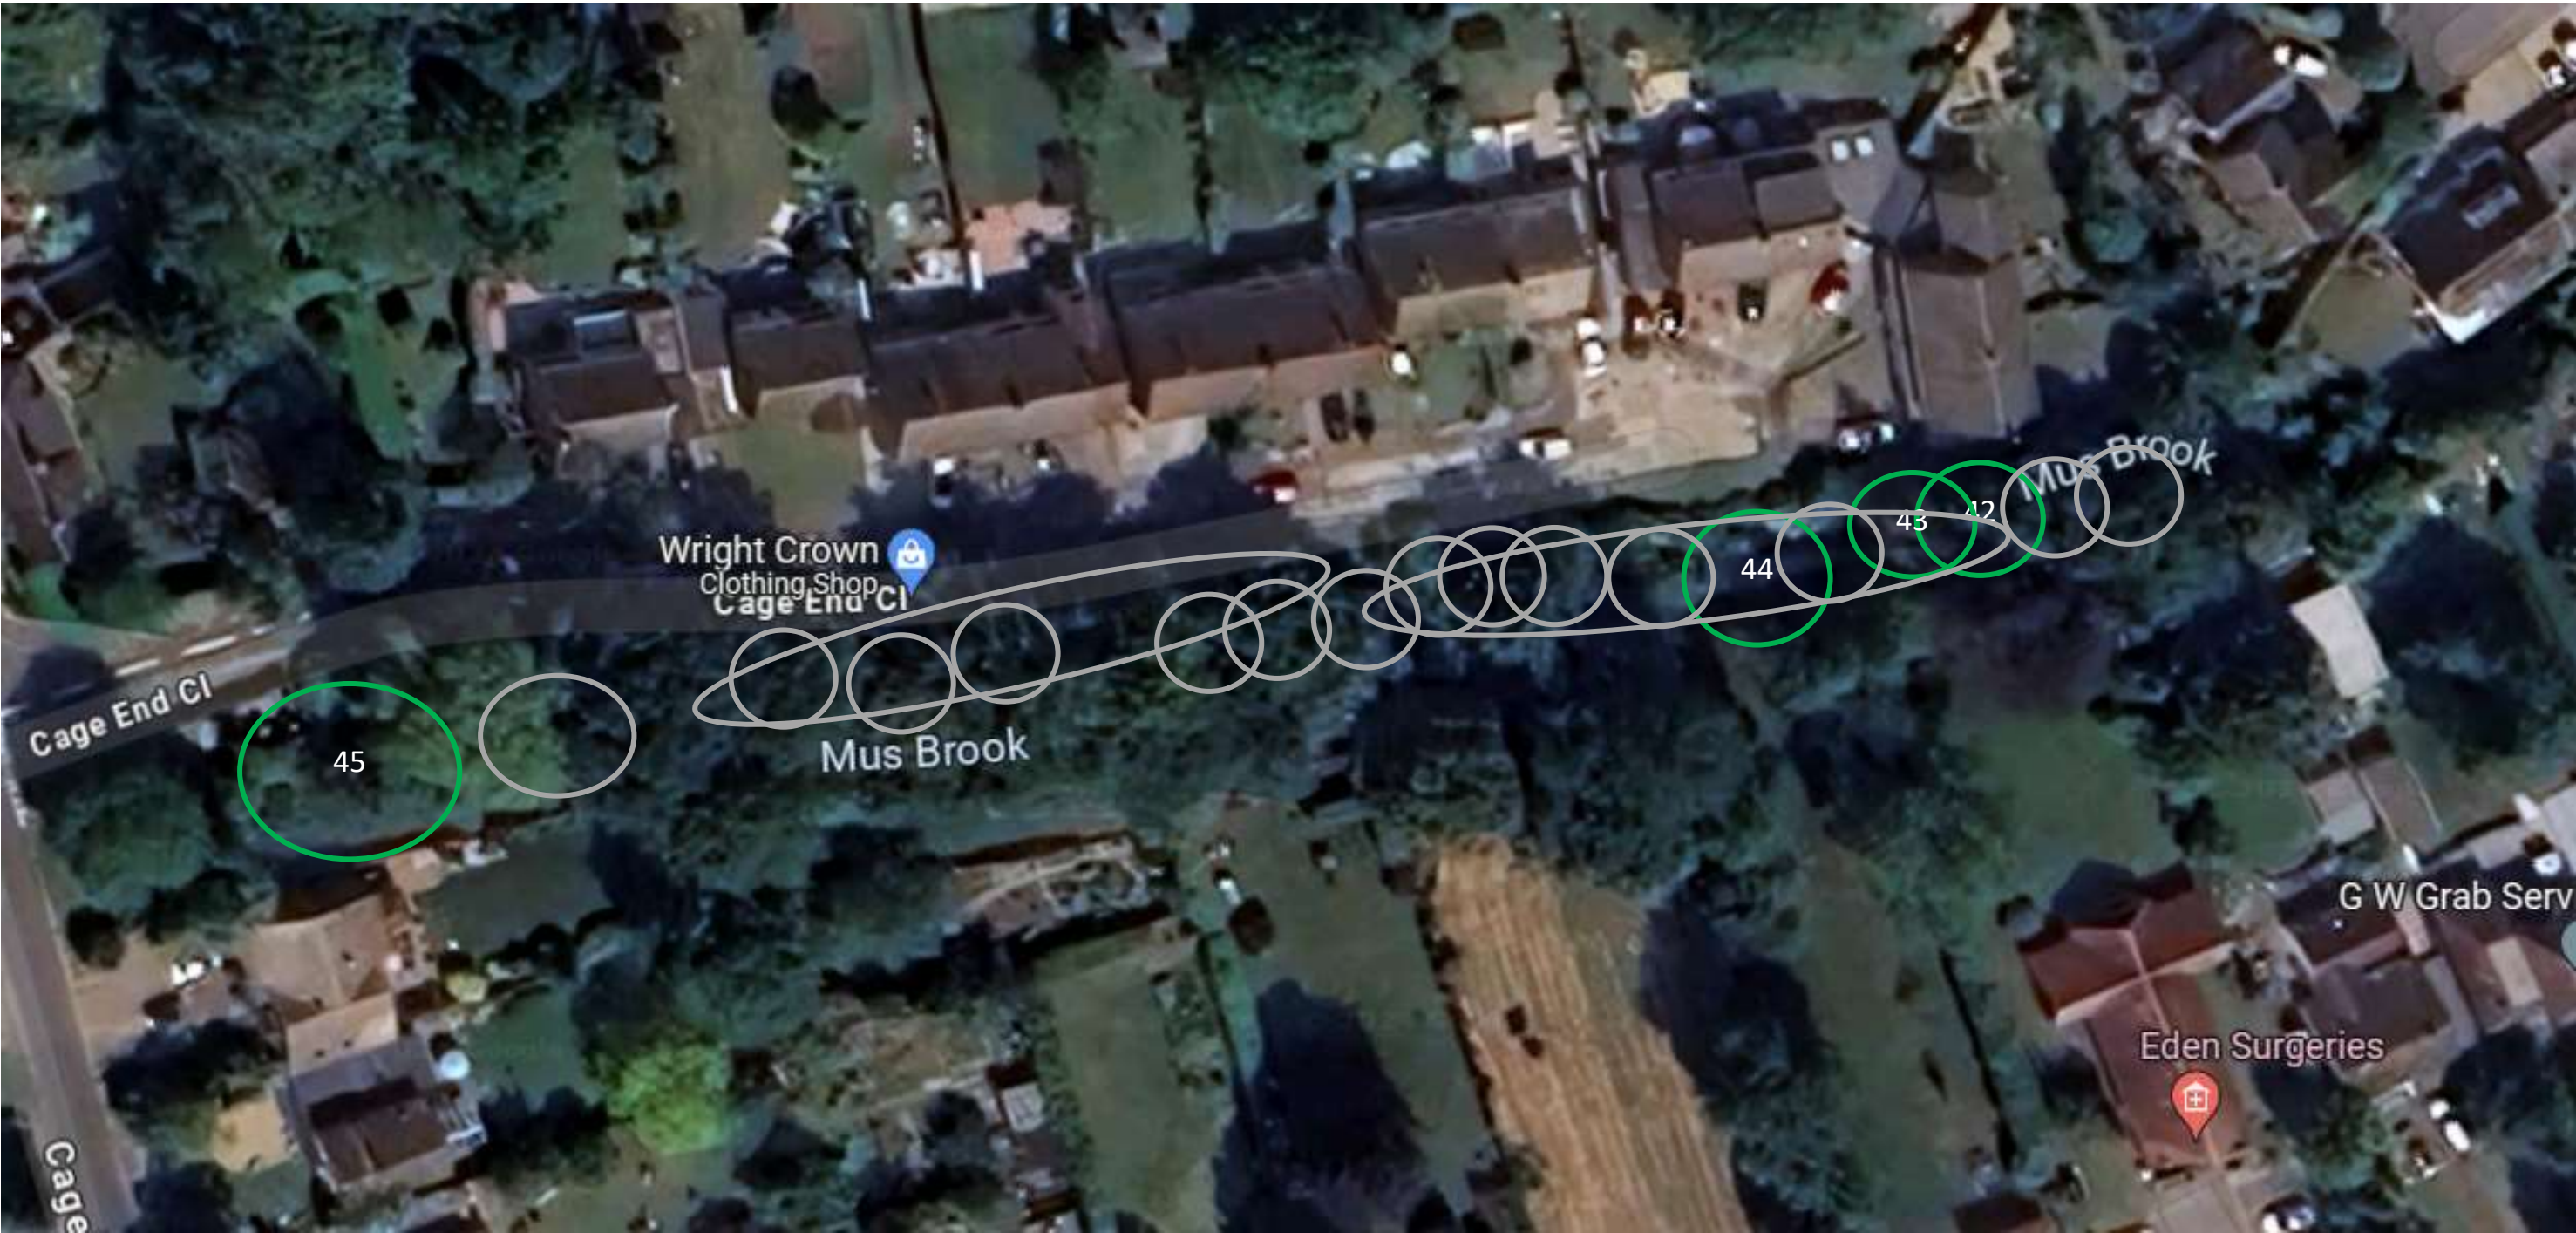
| Tag ref | Map ref | Species | Location | DBH (mm) | Height (m) | Radial crown spread (m) | Age | Crown | Crown break | Stem | Root crown | Rooting area | Overall Condition | Comments | Recommendation(s) | Risk | Priority |
|---|---|---|---|---|---|---|---|---|---|---|---|---|---|---|---|---|---|
| COMPARTMENT 8 OVERVIEW | Stressed and dead trees within the grass area adjacent to the waterway. Works is required to mitigate the risk of collapse which could cause injury to person or property or restrict access | | | | | | | | | | | | | | | | |
