## AGENDA for the meeting of the Open Spaces Management Committee

# Safety Inspection Report

## Water Inspection

Site name: **Pond**  
Date of inspection: **24 May 2024**  
Inspector: **Lewis Heath**

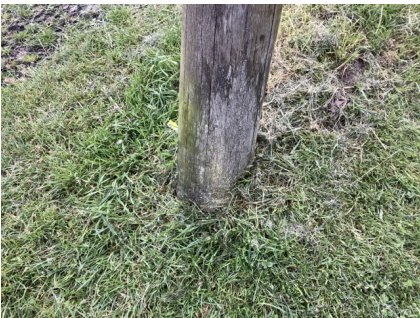
Strimmer damage is present on posts, allowing water to enter and timbers to soften. It can also remove the protective envelope around the timber. Prevent further damage and check timbers for decay throughout the year.

Also mower and arson damage.

Prevent further damage.

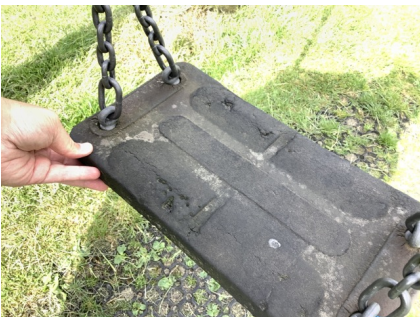
Swing seat rubber is deteriorating / degrading.

Replace when metal is exposed.

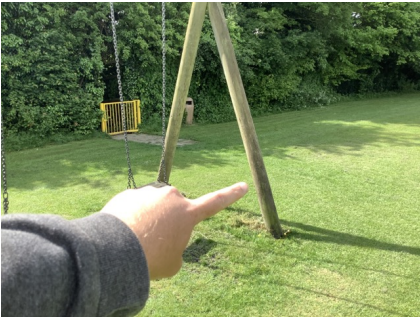
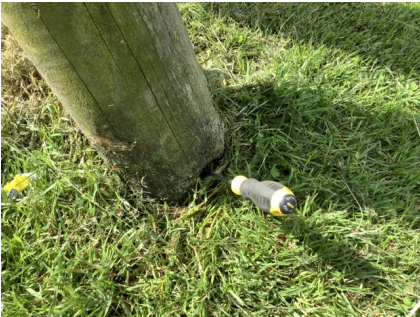
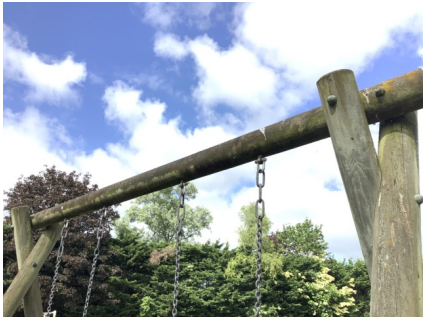
Timber is decayed.

Posts are decaying at ground level. Replace when necessary.  
Slight hollow pitch when tested. Resistance penetrating tested recommended.

We recommend resistance penetration testing to determine the internal condition of the timber. We can undertake this testing at additional cost. Please contact us for details.

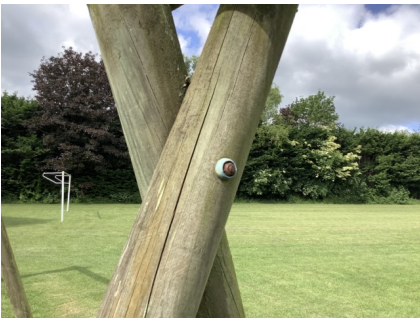
Cap missing.

Replace.

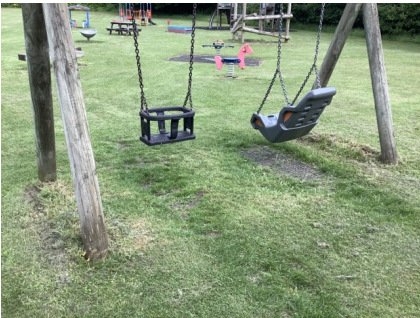
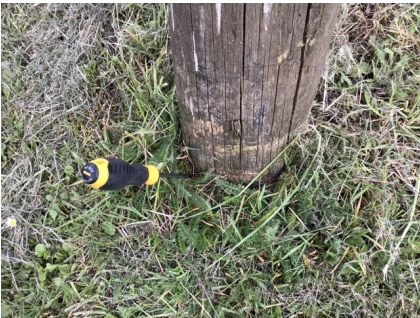
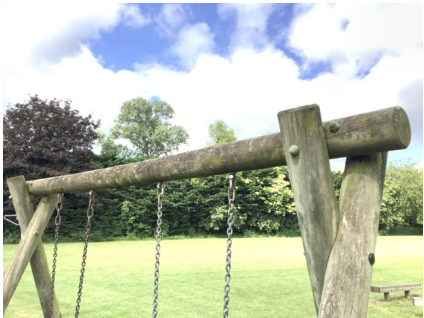
There is decay to timber components which may affect structural integrity. We do not recommend replacing rotten supports with timber posts which are directly set in the ground due to the increased problem of timber rot, especially in posts in contact with the ground.

Monitor all timber items for decay throughout the year due to softening at ground level. Replace affected parts if found.  
Top bar provided a hollow pitch when tested. Resistance penetrating test recommended.

We recommend resistance penetration testing to determine the internal condition of the timber. We can undertake this testing at additional cost. Please contact us for details., Replace decayed components where possible and plan replacement of item. Check on a routine basis, especially at ground or foundation level.

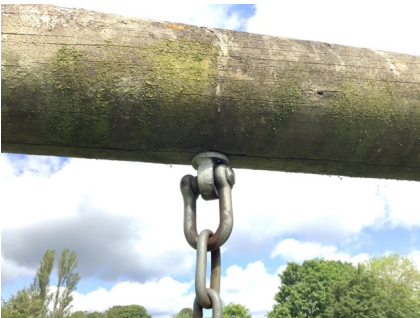
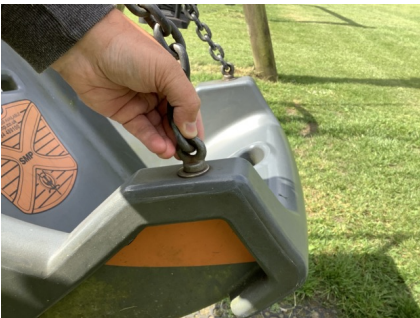
Bolt(s) loose.

Swing hanger/s are loose to top bar and at a slight angle creating excess wear in the future. Secure fittings.  
Eye bolts on accessible seat.

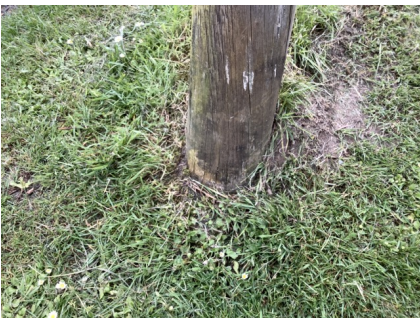
Strimmer damage is present on posts, allowing water to enter and timbers to soften. It can also remove the protective envelope around the timber. Prevent further damage and check timbers for decay throughout the year.

Prevent further damage.

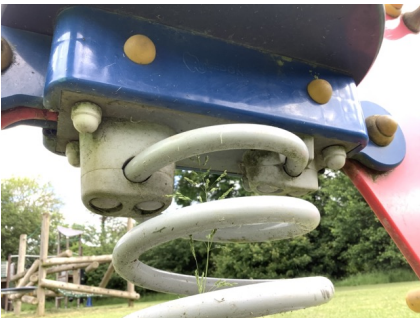
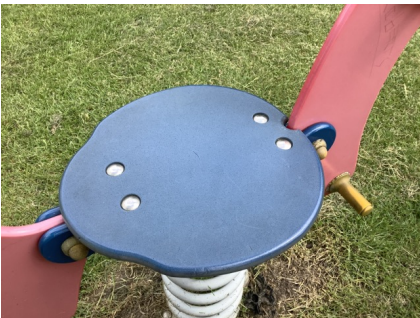
Bolt(s) loose.

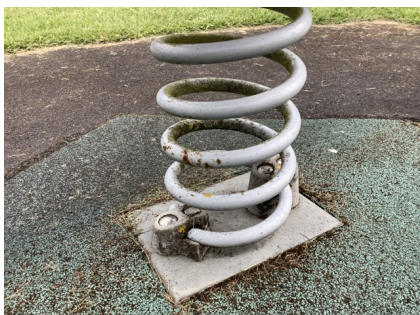
The spring is rusty. These have been known to fail without warning, leading to a collapse of the unit.

Descale.

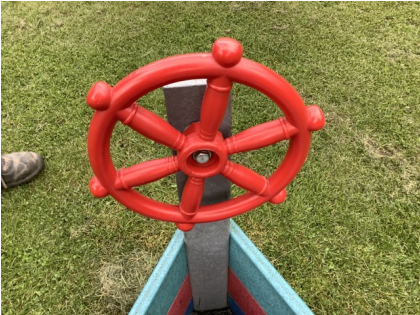
Bolt(s) loose.

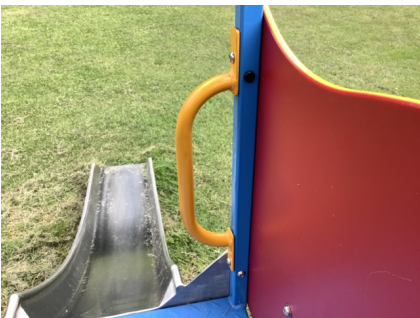
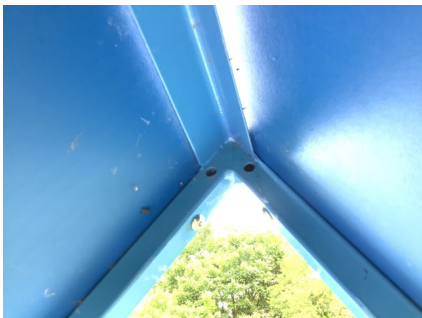
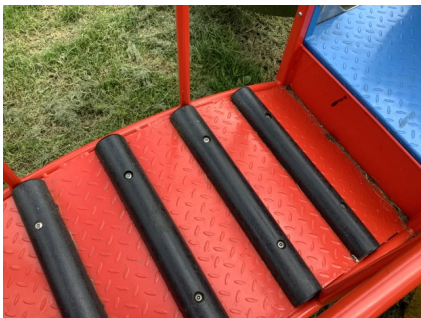
Bolt(s) loose.

Foot holds on bridge and hand hold around slide. Tighten.  
Cap/s are missing allowing water ingress into the frame and fixtures. Replace.

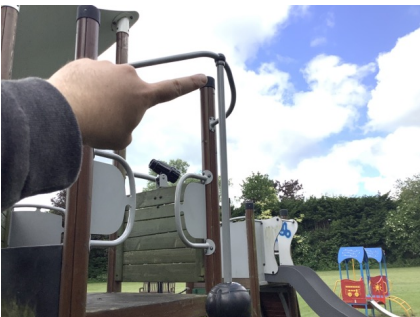
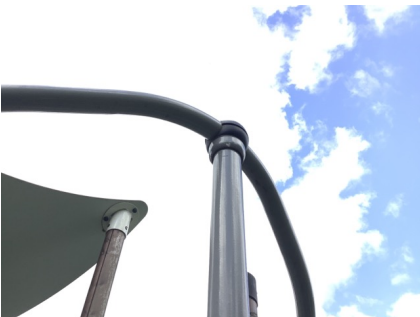
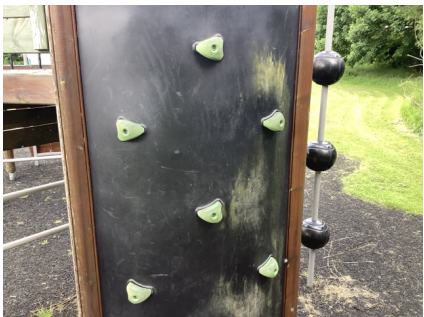
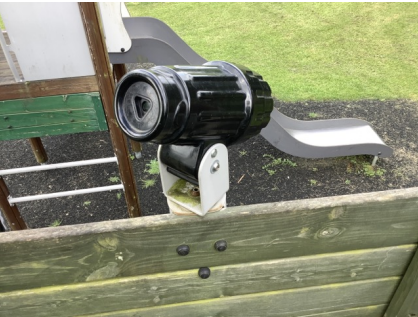
Bolt(s) loose.

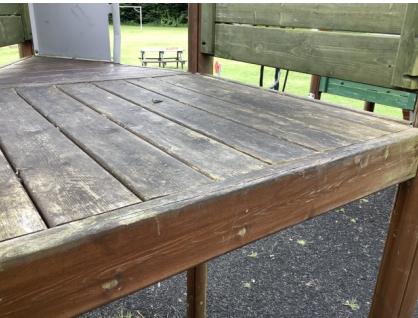
Timber is decayed.

Ramp timber decayed and hollow. Replace.

Replace affected parts.

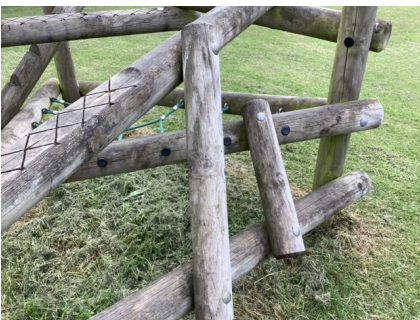
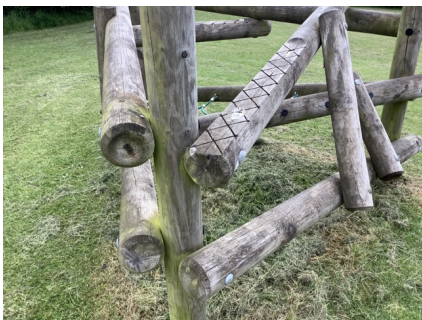
Monitor all natural timber shakes. Shakes are creating slight splintering. Smooth off if necessary.  
Monitor beam due to natural defects allowing water ingress into beams decaying them from the inside outwards.

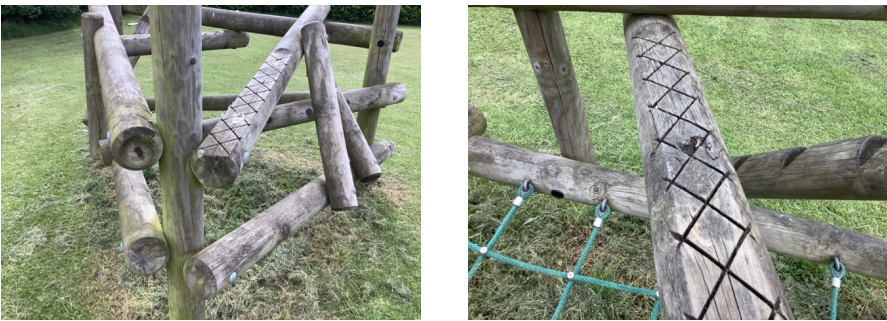
Strimmer damage is present on posts, allowing water to enter and timbers to soften. It can also remove the protective envelope around the timber. Prevent further damage and check timbers for decay throughout the year.

Prevent further damage.

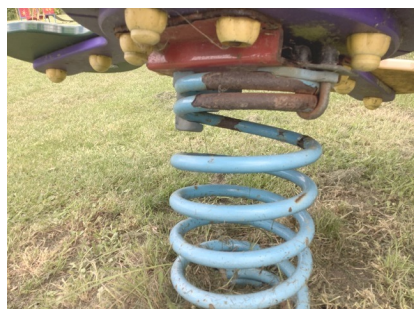
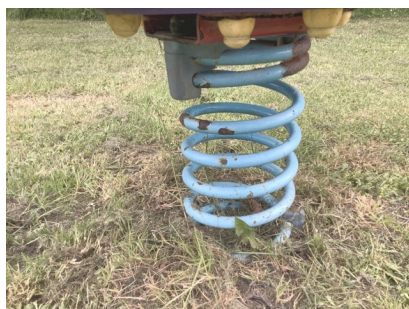
The spring is rusty. These have been known to fail without warning, leading to a collapse of the unit.

Descale/replace.

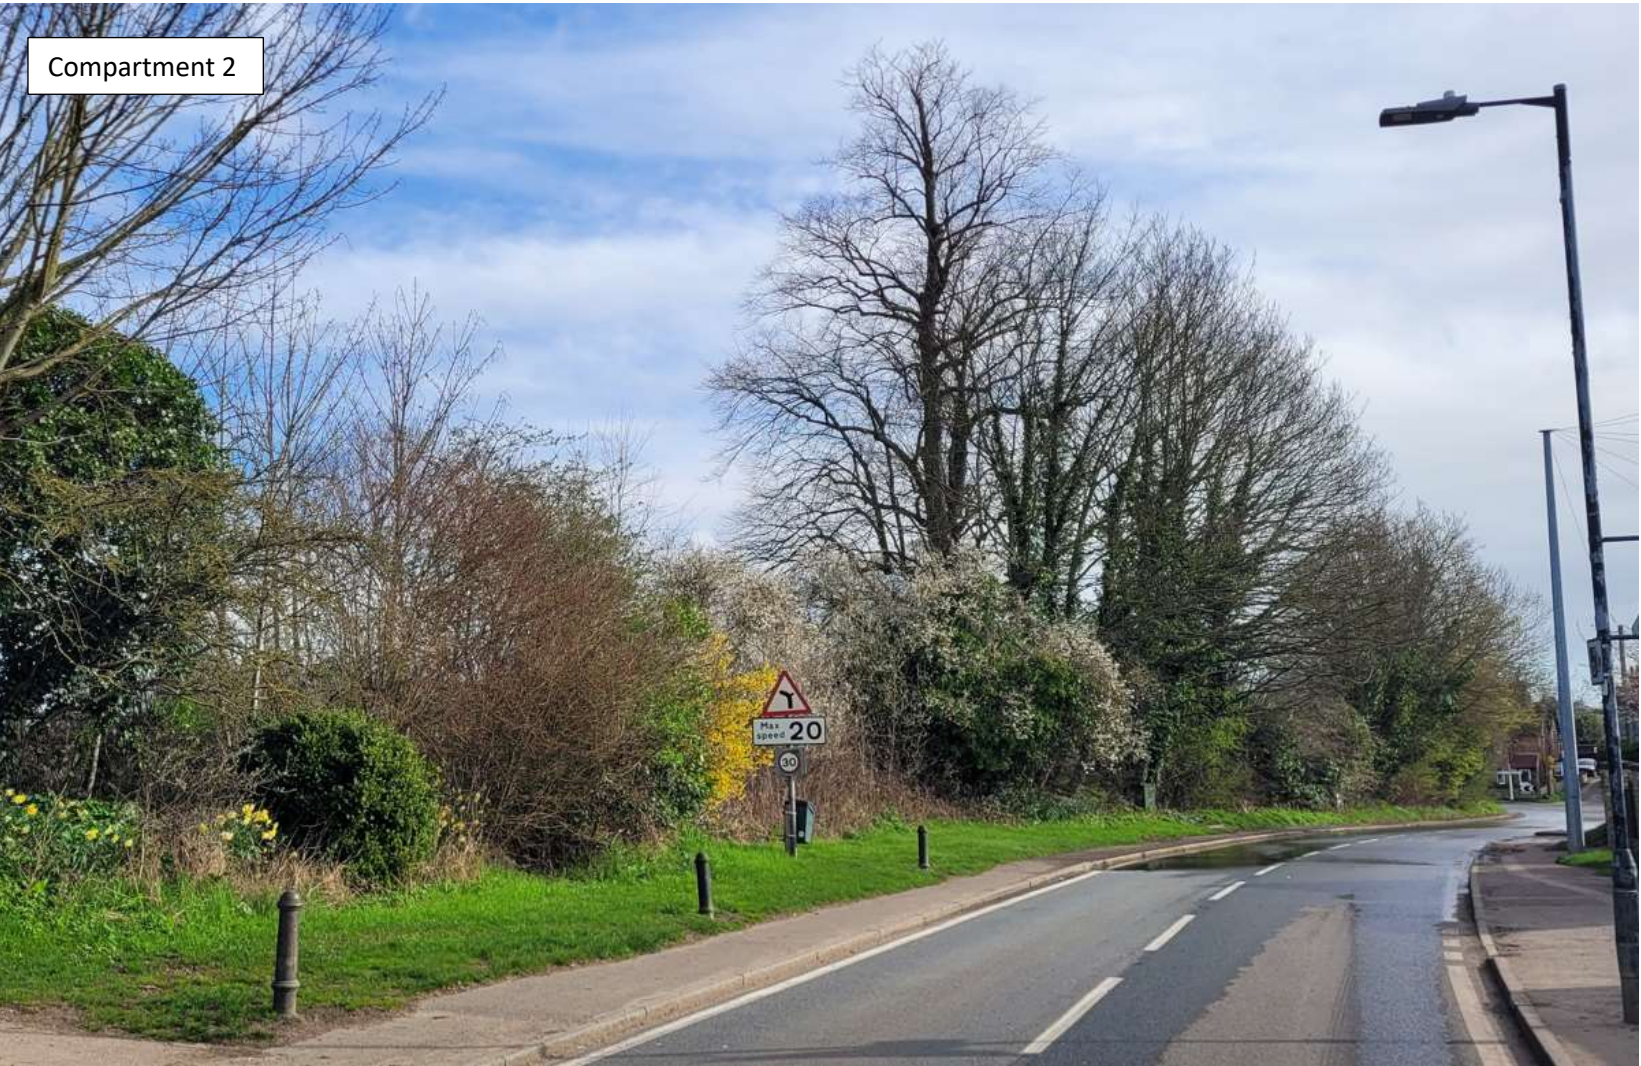
| TS00123_HATBR_5888 | | | | | | | | | | | | | | | | | |
|---|---|---|---|---|---|---|---|---|---|---|---|---|---|---|---|---|---|
| COMPARTMENT 2 OVERVIEW | Sooty bark present within stock this will require monitoring of the Sycamore on an annual basis to gauge the progression. Low growth over road will be a restriction to high sided vehicles sometime within the next 12 month. Flail works apparent but not to extra heavy vehicle height. | | | | | | | | | | | | | | | | |

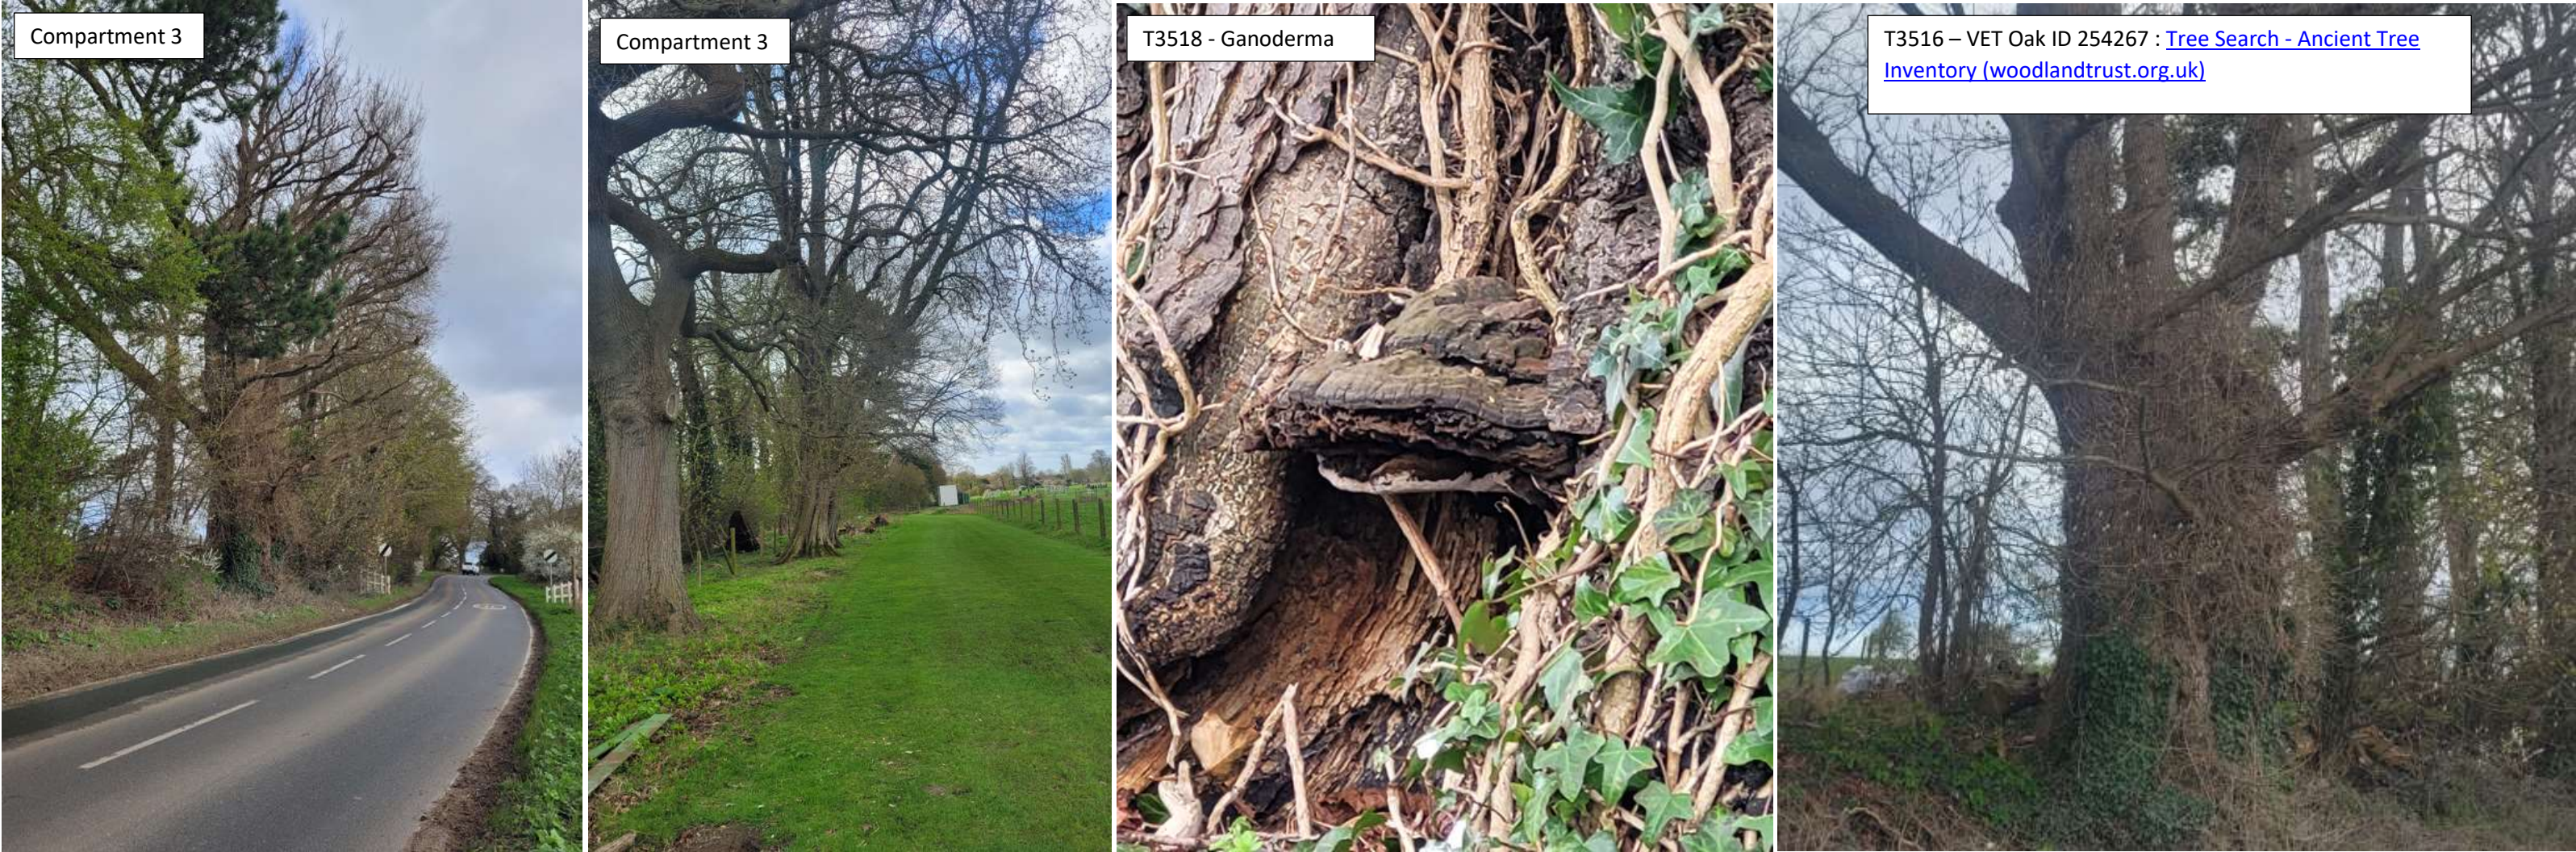
| Tag ref | Map ref | Species | Location | DBH (mm) | Height (m) | Radial crown spread (m) | Age | Crown | Crown break | Stem | Root crown | Rooting area | Overall Condition | Comments | Recommendation(s) | Risk | Priority |
|---|---|---|---|---|---|---|---|---|---|---|---|---|---|---|---|---|---|
| COMPARTMENT 3 OVERVIEW | Sooty bark present within stock this will require monitoring of the Sycamore on an annual basis to gauge the progression. Low growth over road will be a restriction to high sided vehicles sometime within the next 12 month. Flail works apparent but not to extra heavy vehicle height. Group of Horse chestnut found to be in poor condition. Collapse of these would potentially be onto the public carriageway, mitigation works, and annual monitoring required. | | | | | | | | | | | | | | | | |

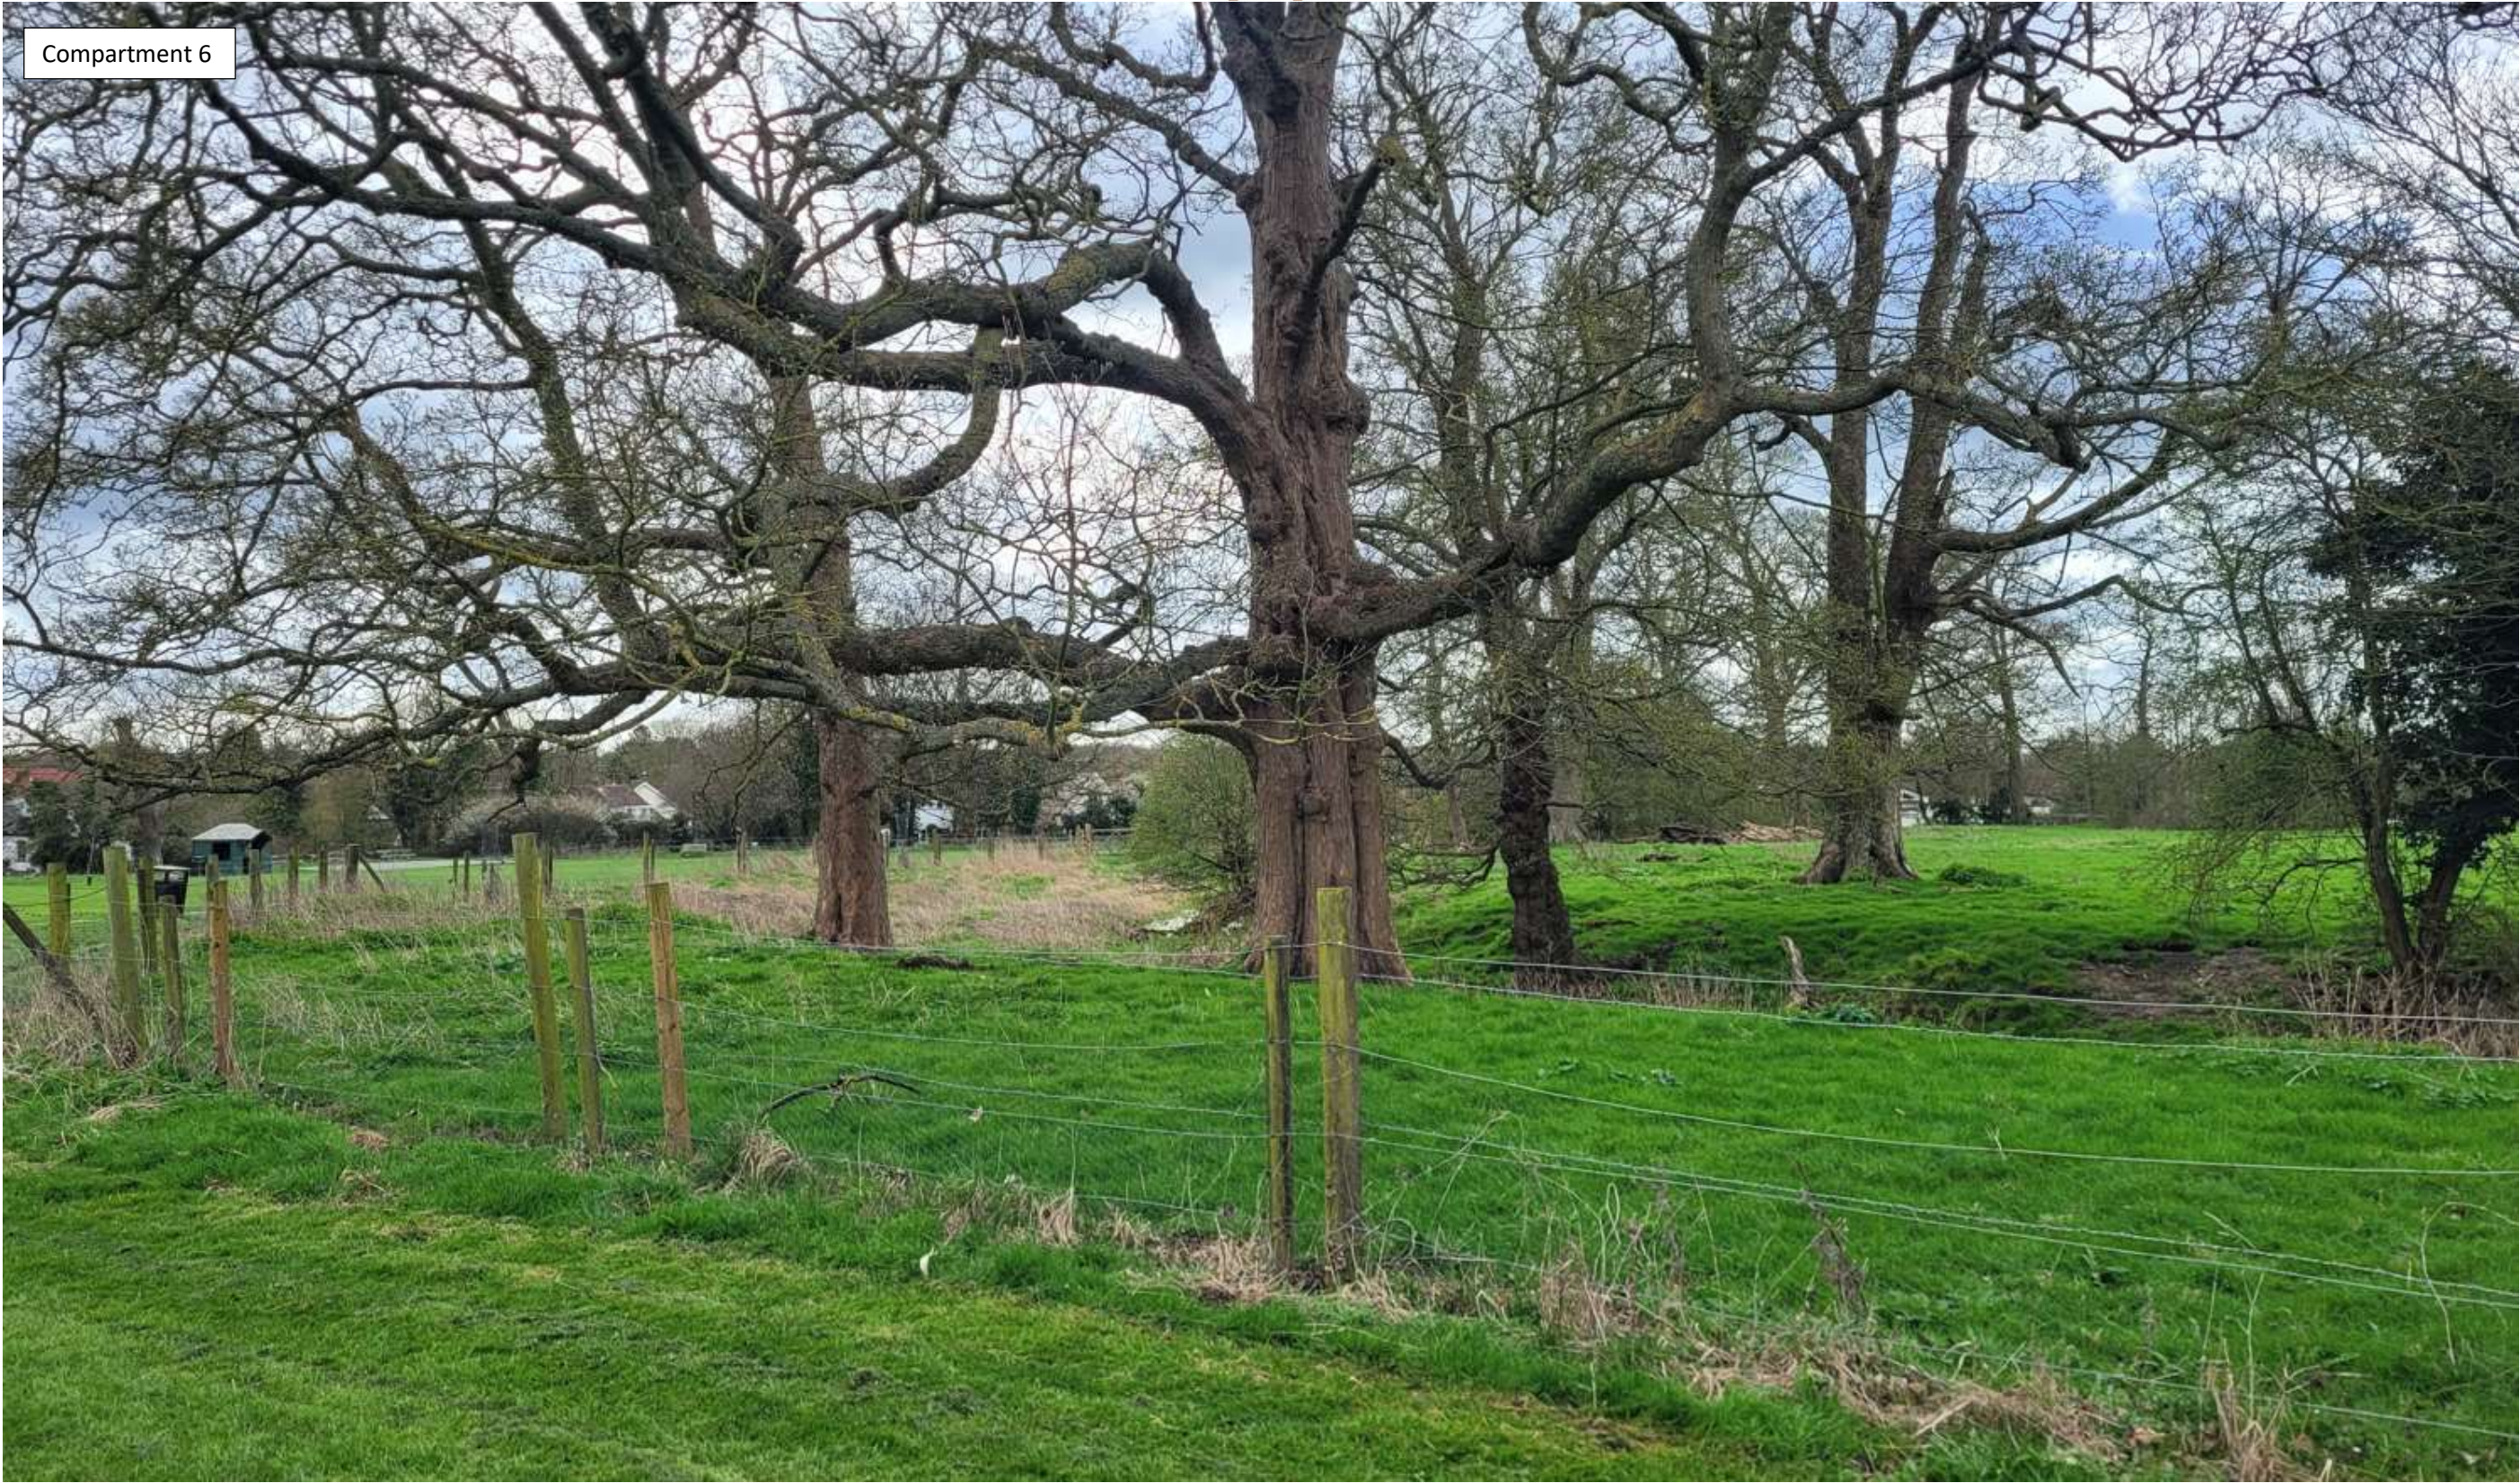
| MAP/ Tag ref | Species | Location | DBH (mm) | Height (m) | Radial crown spread (m) | Age | Crown | Crown break | Stem | Root crown | Rooting area | Overall Condition | Comments | Recommendation(s) | | |
|---|---|---|---|---|---|---|---|---|---|---|---|---|---|---|--|--|
| COMPARTMENT 7 OVERVIEW | No risk associated with land due to tree condition. There are notable issues with the lapsed hedge and shrub adjacent to the waterway, but this is outside of the area of occupation, not considered an arboricultural feature, and away from the play zone. It would be worth considering restricting access to the waterway. | | | | | | | | | | | | | | | |
